Access Compliance Report

Public Rights-of-Way

(Island Curb Cuts)

Intersection ID: 6149	Main Street: STATESVILLE_RD	Cross Street: SUNTRACE_WY	Location: S
ADA ID: 446AD391FA7D	Curb Cut Type: MedianRefuge2	Initial Pass/Fail: Pass	Overall Compliance: No
Codes/Mitigation Info/Possible Solution		Field Measurements/Component Compliance	
Severity Score: 0.25

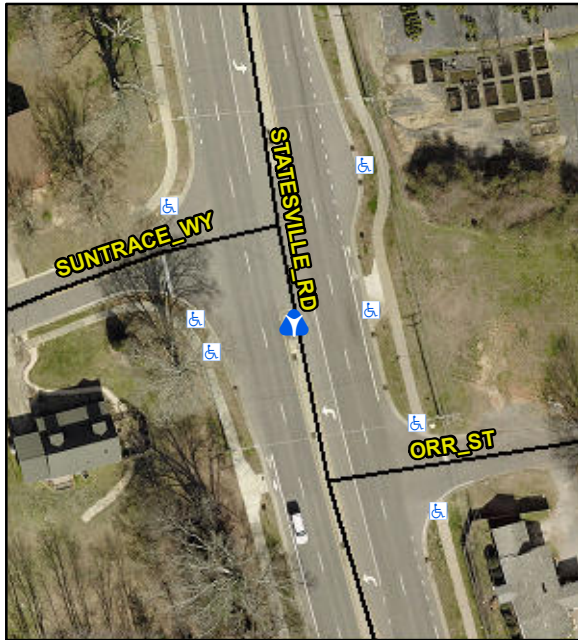
Compliance	Description	Data	Compliance	Description	Data
Yes	Refuge 1 Length (In)	36.0	Yes	Gutter 1 Ponding?	No
Yes	Refuge 1 Width (In)	96.0	No	Gutter 1 Lip Ht (In)	0.25
Yes	Refuge 1 Slope (%)	1.7	Yes	Gutter 1 Slope (%)	0.1
Yes	Refuge 1 X Slope (%)	0.8	Yes	Gutter 1 X Slope (%)	0.7
N/A	Painted X Walk1?	No	Yes	DWS 1 Provided?	Yes
N/A	X Walk 1 Direction	To W	Yes	DWS 1 Contrast?	Yes
N/A	X Walk 1 Width (In)	N/A	Yes	DWS 1 Length (In)	24.0
N/A	Road 1 Slope (%)	0.7	Yes	DWS 1 Full Width?	Yes
N/A	Road 1 X Slope (%)	0.1	Yes	DWS 1 Offset (In)	0.0
Yes	Refuge 2 Length (In)	36.0	Yes	Gutter 2 Ponding?	No
Yes	Refuge 2 Width (In)	96.0	Yes	Gutter 2 Lip Ht (In)	0.0
Yes	Refuge 2 Slope (%)	2.6	Yes	Gutter 2 Slope (%)	1.0
Yes	Refuge 2 X Slope (%)	0.2	Yes	Gutter 2 X Slope (%)	0.4
N/A	Painted X Walk2?	No	Yes	DWS 2 Provided?	Yes
N/A	X Walk 2 Direction	To E	Yes	DWS 2 Contrast?	Yes
N/A	X Walk 2 Width (In)	N/A	Yes	DWS 2 Length (In)	24.0

Possible Solutions:

Grind Gutter Lip.
