Access Compliance Report

Public Rights-of-Way

(Island Curb Cuts)

Intersection ID: 44555	Main Street: UNIVERSITY_CITY_BV	Cross Street: N_TRYON_ST	Location: S
ADA ID: 44A5967BFFB3	Curb Cut Type: MedianRefuge2	Initial Pass/Fail: Pass	Overall Compliance: No Severity Score: 0.25

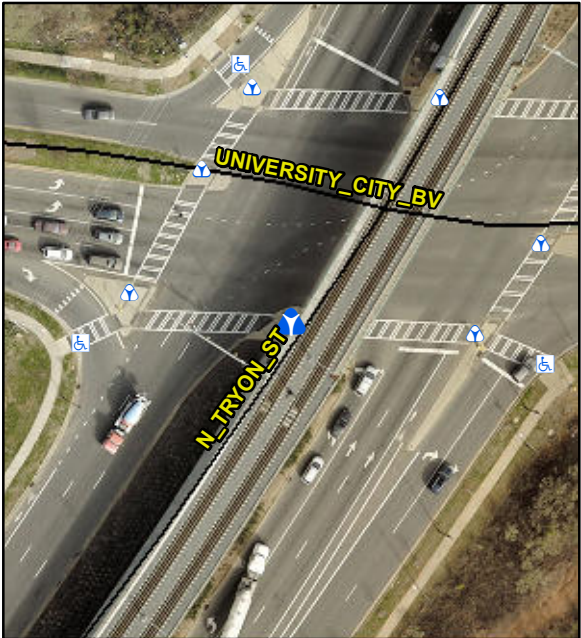
Possible Solutions:		Compliance	Description	Data	
	Grind Gutter Lip.		Yes	Refuge 1 Length (In)	164.0	No
			Yes	Refuge 1 Width (In)	95.0	No
			Yes	Refuge 1 Slope (%)	4.3	Yes
			Yes	Refuge 1 X Slope (%)	1.6	Yes
			N/A	Painted X Walk1?	Yes	Yes
			N/A	X Walk 1 Direction	To W	Yes
			N/A	X Walk 1 Width (In)	124.0	Yes
			N/A	Road 1 Slope (%)	1.5	Yes
			N/A	Road 1 X Slope (%)	1.5	Yes
<p>Surveyor Notes:</p> <p>N/A</p>			Yes	Refuge 2 Length (In)	235.0	No
			Yes	Refuge 2 Width (In)	95.0	No
			Yes	Refuge 2 Slope (%)	0.3	Yes
			Yes	Refuge 2 X Slope (%)	0.6	Yes
			N/A	Painted X Walk2?	Yes	Yes
			N/A	X Walk 2 Direction	To E	Yes
			N/A	X Walk 2 Width (In)	108.0	Yes
			N/A	Road 2 Slope (%)	1.0	Yes
			N/A	Road 2 X Slope (%)	0.1	Yes
			N/A	Refuge 3 Length (in)	N/A	N/A
<p>PROW/ADA:</p> <p>N/A</p>			N/A	Refuge 3 Width (in)	N/A	N/A
			N/A	Refuge 3 Slope (%)	N/A	N/A
