Access Compliance Report

Public Rights-of-Way

(Island Curb Cuts)

Intersection ID: 10027081	Main Street: GALLERIA_BV	Cross Street: N/A	Location: E
ADA ID: 456B37DC09CC	Curb Cut Type: MedianRefuge2	Initial Pass/Fail: Fail	Overall Compliance: No
Codes/Mitigation Info/Possible Solution		Field Measurements/Component Compliance	
Severity Score: 0

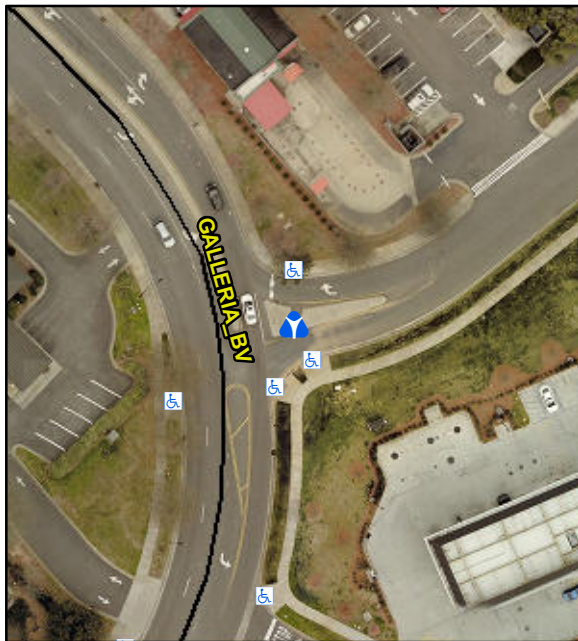
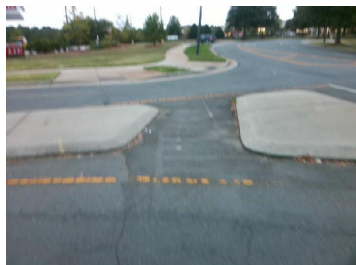
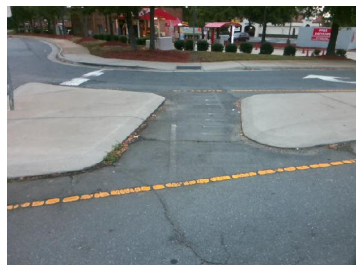
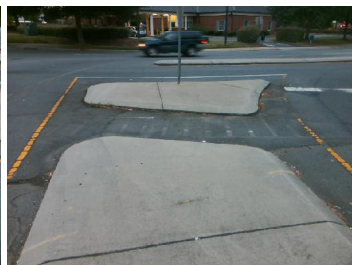
Compliance	Description	Data	Compliance	Description	Data
Yes	Refuge 1 Length (In)	65.0	N/A	Gutter 1 Ponding?	N/A
Yes	Refuge 1 Width (In)	74.0	N/A	Gutter 1 Lip Ht (In)	N/A
Yes	Refuge 1 Slope (%)	0.8	N/A	Gutter 1 Slope (%)	N/A
Yes	Refuge 1 X Slope (%)	2.1	N/A	Gutter 1 X Slope (%)	N/A
N/A	Painted X Walk1?	No	N/A	DWS 1 Provided?	N/A
N/A	X Walk 1 Direction	To N	N/A	DWS 1 Contrast?	N/A
N/A	X Walk 1 Width (In)	N/A	N/A	DWS 1 Length (In)	N/A
N/A	Road 1 Slope (%)	2.4	N/A	DWS 1 Full Width?	N/A
N/A	Road 1 X Slope (%)	0.6	N/A	DWS 1 Offset (In)	N/A
Yes	Refuge 2 Length (In)	65.0	N/A	Gutter 2 Ponding?	N/A
Yes	Refuge 2 Width (In)	74.0	N/A	Gutter 2 Lip Ht (In)	N/A
Yes	Refuge 2 Slope (%)	0.8	N/A	Gutter 2 Slope (%)	N/A
Yes	Refuge 2 X Slope (%)	0.6	N/A	Gutter 2 X Slope (%)	N/A
N/A	Painted X Walk2?	No	N/A	DWS 2 Provided?	N/A
N/A	X Walk 2 Direction	To S	N/A	DWS 2 Contrast?	N/A
N/A	X Walk 2 Width (In)	N/A	N/A	DWS 2 Length (In)	N/A

N/A	Road 2 Slope (%)	0.1	N/A	DWS 2 Full Width?	N/A
N/A	Road 2 X Slope (%)	1.7	N/A	DWS 2 Offset (In)	N/A
N/A	Refuge 3 Length (in)	N/A	N/A	Gutter 3 Ponding?	N/A
N/A	Refuge 3 Width (in)	N/A	N/A	Gutter 3 Lip Ht (in)	N/A
N/A	Refuge 3 Slope (%)	N/A	N/A	Gutter 3 Slope (%)	N/A
N/A	Refuge 3 XSlope (%)	N/A	N/A	Gutter 3 XSlope (%)	N/A
N/A	Painted X Walk3?	N/A	N/A	DWS 3 Provided?	N/A
N/A	X Walk 3 Direction	N/A	N/A	DWS 3 Contrast?	N/A
N/A	X Walk 3 Width (in)	N/A	N/A	DWS 3 Length (in)	N/A
N/A	Road 3 Slope (%)	N/A	N/A	DWS 3 Full Width?	N/A
N/A	Road 3 XSlope (%)	N/A	N/A	DWS 3 Offset (in)	N/A
Yes	Any Obstructions?	N/A	N/A	Storm Grate/Utility Hazard?	N/A
N/A	Obstruction Type		N/A	Storm Grate/Utility Type	
		N/A			N/A
N/A	Surface Condition	Good

Possible Solutions:

Remove & Replace Entire Refuge.
