# Access Compliance Report

## Public Rights-of-Way

### (Island Curb Cuts)

| Intersection ID: 17513 | Main Street: PROVIDENCE_DR | Cross Street: PROVIDENCE_RD | Location: SE |

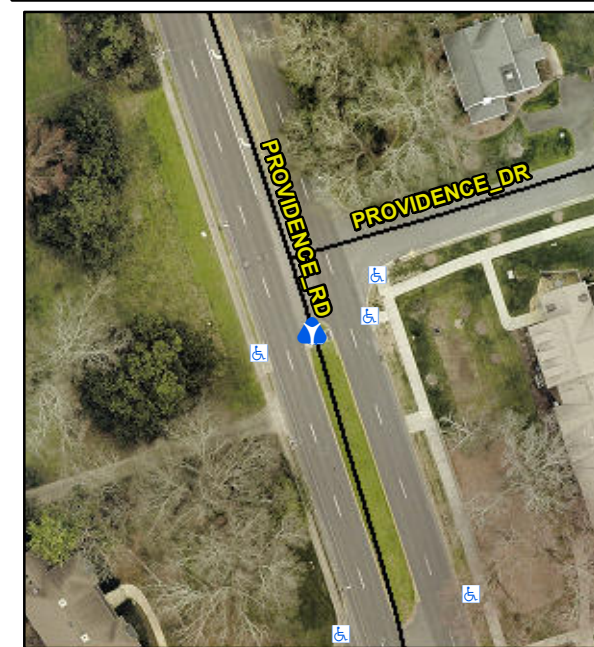
| ADA ID: 46AB6E241666 | Curb Cut Type: MedianRefuge2 | Initial Pass/Fail: Fail | Overall Compliance: No |

| Compliance | Description | Data | Compliance | Description | Data |
|---|---|---|---|---|---|
| No | Refuge 1 Width (In) | 59.0 | N/A | Gutter 1 Lip Ht (In) | N/A |
| No | Refuge 1 X Slope (%) | 5.2 | N/A | Gutter 1 X Slope (%) | N/A |
| No | Refuge 2 Width (In) | 59.0 | N/A | Gutter 2 Lip Ht (In) | N/A |
| No | Refuge 2 X Slope (%) | 6.9 | N/A | Gutter 2 X Slope (%) | N/A |

**Remove & Replace Entire Refuge.**

Total Cost: \$ 3000.00
