Access Compliance Report

Public Rights-of-Way

(Island Curb Cuts)

Intersection ID: 10032865	Main Street: NATIONS_FORD_RD	Cross Street: N/A	Location: S
ADA ID: 46E23164C97A	Curb Cut Type: MedianRefuge2	Initial Pass/Fail: Pass	Overall Compliance: Yes
Codes/Mitigation Info/Possible Solution		Field Measurements/Component Compliance	
Severity Score: 0.25

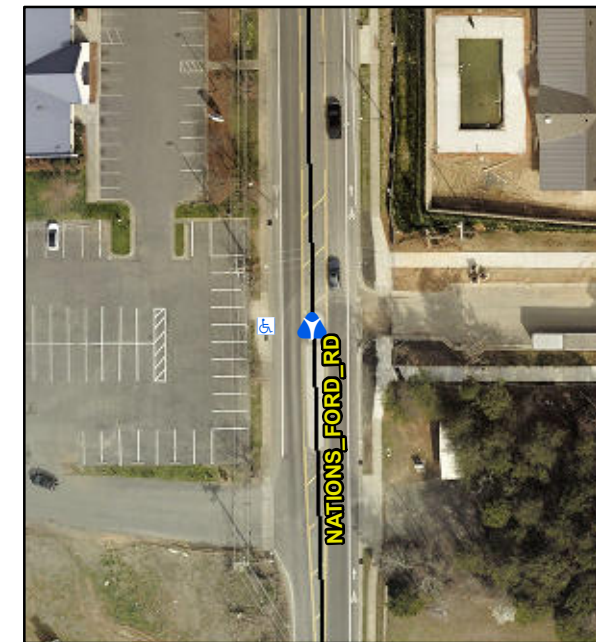
Compliance	Description	Data	Compliance	Description	Data
Yes	Refuge 1 Length (In)	57.5	Yes	Gutter 1 Ponding?	No
Yes	Refuge 1 Width (In)	100.0	Yes	Gutter 1 Lip Ht (In)	0.0
Yes	Refuge 1 Slope (%)	2.3	Yes	Gutter 1 Slope (%)	2.6
Yes	Refuge 1 X Slope (%)	0.2	Yes	Gutter 1 X Slope (%)	0.5
N/A	Painted X Walk1?	No	Yes	DWS 1 Provided?	Yes
N/A	X Walk 1 Direction	To E	Yes	DWS 1 Contrast?	Yes
N/A	X Walk 1 Width (In)	N/A	Yes	DWS 1 Length (In)	24.0
N/A	Road 1 Slope (%)	1.2	Yes	DWS 1 Full Width?	Yes
N/A	Road 1 X Slope (%)	2.7	Yes	DWS 1 Offset (In)	0.0
Yes	Refuge 2 Length (In)	57.5	Yes	Gutter 2 Ponding?	No
Yes	Refuge 2 Width (In)	100.0	Yes	Gutter 2 Lip Ht (In)	0.0
Yes	Refuge 2 Slope (%)	1.2	Yes	Gutter 2 Slope (%)	2.9
Yes	Refuge 2 X Slope (%)	0.7	Yes	Gutter 2 X Slope (%)	0.7
N/A	Painted X Walk2?	No	Yes	DWS 2 Provided?	Yes
N/A	X Walk 2 Direction	To W	Yes	DWS 2 Contrast?	Yes
N/A	X Walk 2 Width (In)	N/A	Yes	DWS 2 Length (In)	24.0

N/A	Road 2 Slope (%)	0.2	Yes	DWS 2 Full Width?	Yes
N/A	Road 2 X Slope (%)	1.7	Yes	DWS 2 Offset (In)	0.0
N/A	Refuge 3 Length (in)	N/A	N/A	Gutter 3 Ponding?	N/A
N/A	Refuge 3 Width (in)	N/A	N/A	Gutter 3 Lip Ht (in)	N/A
N/A	Refuge 3 Slope (%)	N/A	N/A	Gutter 3 Slope (%)	N/A
N/A	Refuge 3 XSlope (%)	N/A	N/A	Gutter 3 XSlope (%)	N/A
N/A	Painted X Walk3?	N/A	N/A	DWS 3 Provided?	N/A
N/A	X Walk 3 Direction	N/A	N/A	DWS 3 Contrast?	N/A
N/A	X Walk 3 Width (in)	N/A	N/A	DWS 3 Length (in)	N/A
N/A	Road 3 Slope (%)	N/A	N/A	DWS 3 Full Width?	N/A
N/A	Road 3 XSlope (%)	N/A	N/A	DWS 3 Offset (in)	N/A
Yes	Any Obstructions?	N/A	N/A	Storm Grate/Utility Hazard?	No
N/A	Obstruction Type		N/A	Storm Grate/Utility Type	
		N/A			N/A
N/A	Surface Condition	Good

N/A
