Access Compliance Report

Public Rights-of-Way

(Island Curb Cuts)

Intersection ID: 5832	Main Street: N_TRYON_ST	Cross Street: KEN_HOFFMAN_DR	Location: E
ADA ID: 480569762C3E	Curb Cut Type: MedianRefuge2	Initial Pass/Fail: Fail	Overall Compliance: No
Codes/Mitigation Info/Possible Solution		Field Measurements/Component Compliance	
Severity Score: 25

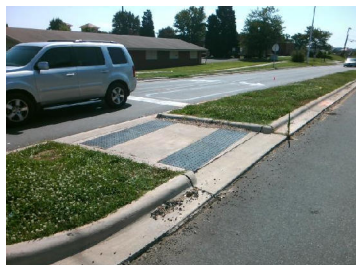
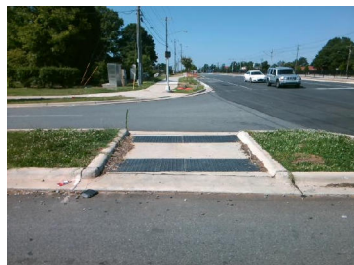
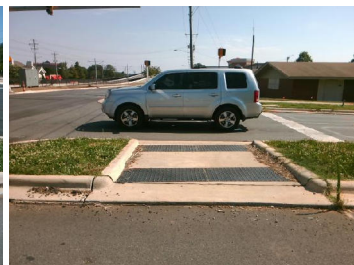
Compliance	Description	Data	Compliance	Description	Data
Yes	Refuge 1 Length (In)	48.0	N/A	Gutter 1 Ponding?	N/A
Yes	Refuge 1 Width (In)	96.0	N/A	Gutter 1 Lip Ht (In)	N/A
Yes	Refuge 1 Slope (%)	4.2	N/A	Gutter 1 Slope (%)	N/A
Yes	Refuge 1 X Slope (%)	0.2	N/A	Gutter 1 X Slope (%)	N/A
N/A	Painted X Walk1?	No	N/A	DWS 1 Provided?	N/A
N/A	X Walk 1 Direction	To NE	N/A	DWS 1 Contrast?	N/A
N/A	X Walk 1 Width (In)	N/A	N/A	DWS 1 Length (In)	N/A
N/A	Road 1 Slope (%)	0.9	N/A	DWS 1 Full Width?	N/A
N/A	Road 1 X Slope (%)	2.6	N/A	DWS 1 Offset (In)	N/A
Yes	Refuge 2 Length (In)	48.0	N/A	Gutter 2 Ponding?	N/A
Yes	Refuge 2 Width (In)	96.0	N/A	Gutter 2 Lip Ht (In)	N/A
No	Refuge 2 Slope (%)	10.4	N/A	Gutter 2 Slope (%)	N/A
Yes	Refuge 2 X Slope (%)	1.0	N/A	Gutter 2 X Slope (%)	N/A
N/A	Painted X Walk2?	No	N/A	DWS 2 Provided?	N/A
N/A	X Walk 2 Direction	To SW	N/A	DWS 2 Contrast?	N/A
N/A	X Walk 2 Width (In)	N/A	N/A	DWS 2 Length (In)	N/A

N/A	Road 2 Slope (%)	0.9	N/A	DWS 2 Full Width?	N/A
N/A	Road 2 X Slope (%)	1.5	N/A	DWS 2 Offset (In)	N/A
N/A	Refuge 3 Length (in)	N/A	N/A	Gutter 3 Ponding?	N/A
N/A	Refuge 3 Width (in)	N/A	N/A	Gutter 3 Lip Ht (in)	N/A
N/A	Refuge 3 Slope (%)	N/A	N/A	Gutter 3 Slope (%)	N/A
N/A	Refuge 3 XSlope (%)	N/A	N/A	Gutter 3 XSlope (%)	N/A
N/A	Painted X Walk3?	No	N/A	DWS 3 Provided?	N/A
N/A	X Walk 3 Direction	N/A	N/A	DWS 3 Contrast?	N/A
N/A	X Walk 3 Width (in)	N/A	N/A	DWS 3 Length (in)	N/A
N/A	Road 3 Slope (%)	N/A	N/A	DWS 3 Full Width?	N/A
N/A	Road 3 XSlope (%)	N/A	N/A	DWS 3 Offset (in)	N/A
Yes	Any Obstructions?	N/A	N/A	Storm Grate/Utility Hazard?	N/A
N/A	Obstruction Type		N/A	Storm Grate/Utility Type	
		N/A			N/A
N/A	Surface Condition	Good

Remove & Replace Entire Refuge.
