Access Compliance Report

Public Rights-of-Way

(Island Curb Cuts)

Intersection ID: 10579	Main Street: RUSH_AV	Cross Street: TUCKASEEGEE_RD	Location: SW
ADA ID: 4A42579BDD9E	Curb Cut Type: MedianRefuge2	Initial Pass/Fail: Fail	Overall Compliance: No
Codes/Mitigation Info/Possible Solution		Field Measurements/Component Compliance	
Severity Score: 12.5

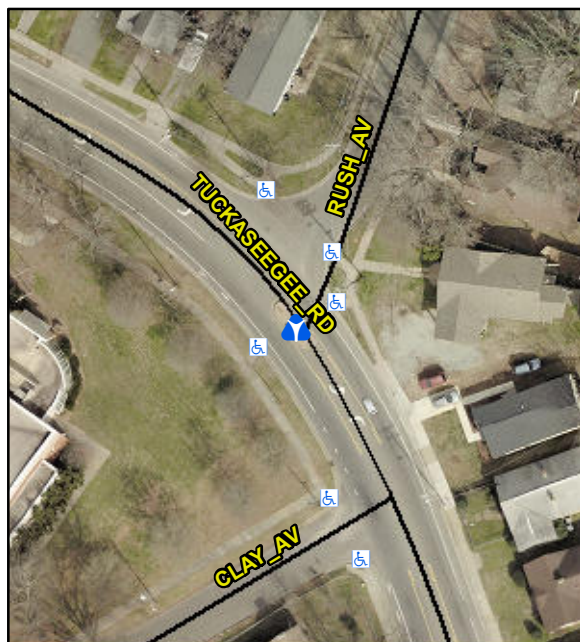
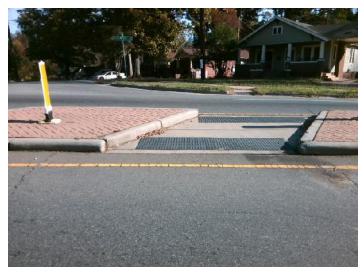
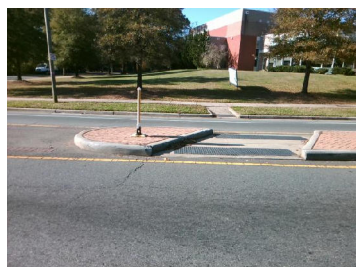
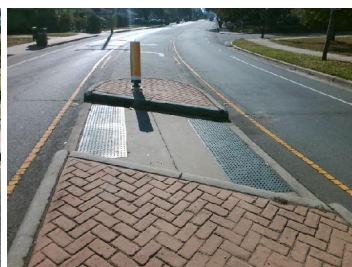
Compliance	Description	Data	Compliance	Description	Data
Yes	Refuge 1 Length (In)	54.0	N/A	Gutter 1 Ponding?	N/A
Yes	Refuge 1 Width (In)	109.0	N/A	Gutter 1 Lip Ht (In)	N/A
No	Refuge 1 Slope (%)	5.5	N/A	Gutter 1 Slope (%)	N/A
Yes	Refuge 1 X Slope (%)	1.4	N/A	Gutter 1 X Slope (%)	N/A
N/A	Painted X Walk1?	No	N/A	DWS 1 Provided?	N/A
N/A	X Walk 1 Direction	To SW	N/A	DWS 1 Contrast?	N/A
N/A	X Walk 1 Width (In)	N/A	N/A	DWS 1 Length (In)	N/A
N/A	Road 1 Slope (%)	1.8	N/A	DWS 1 Full Width?	N/A
N/A	Road 1 X Slope (%)	6.9	N/A	DWS 1 Offset (In)	N/A
Yes	Refuge 2 Length (In)	54.0	N/A	Gutter 2 Ponding?	N/A
Yes	Refuge 2 Width (In)	109.0	N/A	Gutter 2 Lip Ht (In)	N/A
Yes	Refuge 2 Slope (%)	3.1	N/A	Gutter 2 Slope (%)	N/A
Yes	Refuge 2 X Slope (%)	2.4	N/A	Gutter 2 X Slope (%)	N/A
N/A	Painted X Walk2?	No	N/A	DWS 2 Provided?	N/A
N/A	X Walk 2 Direction	To NE	N/A	DWS 2 Contrast?	N/A
N/A	X Walk 2 Width (In)	N/A	N/A	DWS 2 Length (In)	N/A

N/A	Road 2 Slope (%)	1.8	N/A	DWS 2 Full Width?	N/A
N/A	Road 2 X Slope (%)	1.7	N/A	DWS 2 Offset (In)	N/A
N/A	Refuge 3 Length (in)	N/A	N/A	Gutter 3 Ponding?	N/A
N/A	Refuge 3 Width (in)	N/A	N/A	Gutter 3 Lip Ht (in)	N/A
N/A	Refuge 3 Slope (%)	N/A	N/A	Gutter 3 Slope (%)	N/A
N/A	Refuge 3 XSlope (%)	N/A	N/A	Gutter 3 XSlope (%)	N/A
N/A	Painted X Walk3?	N/A	N/A	DWS 3 Provided?	N/A
N/A	X Walk 3 Direction	N/A	N/A	DWS 3 Contrast?	N/A
N/A	X Walk 3 Width (in)	N/A	N/A	DWS 3 Length (in)	N/A
N/A	Road 3 Slope (%)	N/A	N/A	DWS 3 Full Width?	N/A
N/A	Road 3 XSlope (%)	N/A	N/A	DWS 3 Offset (in)	N/A
Yes	Any Obstructions?	N/A	N/A	Storm Grate/Utility Hazard?	N/A
N/A	Obstruction Type		N/A	Storm Grate/Utility Type	
		N/A			N/A
N/A	Surface Condition	Good

Remove & Replace Entire Refuge.
