# Access Compliance Report

## Public Rights-of-Way

### (Island Curb Cuts)

Intersection ID: 11112	Main Street: WILKINSON_BV	Cross Street: LITTLE ROCK_RD	Location: NE
ADA ID: 4B5F6981438A	Curb Cut Type: MedianRefuge2	Initial Pass/Fail: Fail	Overall Compliance: No
Severity Score: 0			
Codes/Mitigation Info/Possible Solution		Field Measurements/Component Compliance

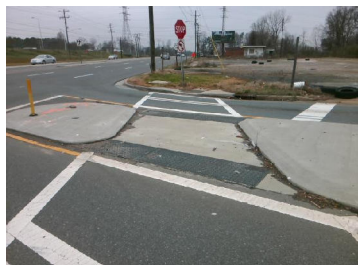
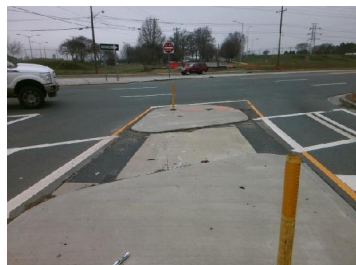
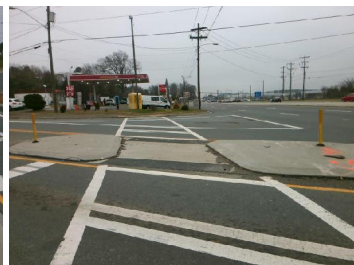
Compliance	Description	Data	Compliance	Description	Data
Yes	Refuge 1 Length (In)	80.0	N/A	Gutter 1 Ponding?	N/A
Yes	Refuge 1 Width (In)	118.0	N/A	Gutter 1 Lip Ht (In)	N/A
Yes	Refuge 1 Slope (%)	0.6	N/A	Gutter 1 Slope (%)	N/A
Yes	Refuge 1 X Slope (%)	2.5	N/A	Gutter 1 X Slope (%)	N/A
N/A	Painted X Walk1?	Yes	N/A	DWS 1 Provided?	N/A
N/A	X Walk 1 Direction	To E	N/A	DWS 1 Contrast?	N/A
N/A	X Walk 1 Width (In)	112.0	N/A	DWS 1 Length (In)	N/A
N/A	Road 1 Slope (%)	2.8	N/A	DWS 1 Full Width?	N/A
N/A	Road 1 X Slope (%)	1.2	N/A	DWS 1 Offset (In)	N/A
Yes	Refuge 2 Length (In)	80.0	N/A	Gutter 2 Ponding?	N/A
Yes	Refuge 2 Width (In)	118.0	N/A	Gutter 2 Lip Ht (In)	N/A
Yes	Refuge 2 Slope (%)	2.0	N/A	Gutter 2 Slope (%)	N/A
Yes	Refuge 2 X Slope (%)	2.9	N/A	Gutter 2 X Slope (%)	N/A
N/A	Painted X Walk2?	Yes	N/A	DWS 2 Provided?	N/A
N/A	X Walk 2 Direction	To W	N/A	DWS 2 Contrast?	N/A
N/A	X Walk 2 Width (In)	112.0	N/A	DWS 2 Length (In)	N/A

N/A	Road 2 Slope (%)	1.5	N/A	DWS 2 Full Width?	N/A
N/A	Road 2 X Slope (%)	5.4	N/A	DWS 2 Offset (In)	N/A
N/A	Refuge 3 Length (in)	N/A	N/A	Gutter 3 Ponding?	N/A
N/A	Refuge 3 Width (in)	N/A	N/A	Gutter 3 Lip Ht (in)	N/A
N/A	Refuge 3 Slope (%)	N/A	N/A	Gutter 3 Slope (%)	N/A
N/A	Refuge 3 XSlope (%)	N/A	N/A	Gutter 3 XSlope (%)	N/A
N/A	Painted X Walk3?	N/A	N/A	DWS 3 Provided?	N/A
N/A	X Walk 3 Direction	N/A	N/A	DWS 3 Contrast?	N/A
N/A	X Walk 3 Width (in)	N/A	N/A	DWS 3 Length (in)	N/A
N/A	Road 3 Slope (%)	N/A	N/A	DWS 3 Full Width?	N/A
N/A	Road 3 XSlope (%)	N/A	N/A	DWS 3 Offset (in)	N/A
Yes	Any Obstructions?	N/A	N/A	Storm Grate/Utility Hazard?	N/A
N/A	Obstruction Type		N/A	Storm Grate/Utility Type	
		N/A			N/A
N/A	Surface Condition	Good

**Remove & Replace Entire Refuge.**
