Access Compliance Report

Public Rights-of-Way

(Island Curb Cuts)

Intersection ID: 21411	Main Street: MONROE_RD	Cross Street: SARDIS_RD_NORTH	Location: SE
ADA ID: 4C5626F1BE25	Curb Cut Type: IslandRefuge3	Initial Pass/Fail: Fail	Overall Compliance: No
Codes/Mitigation Info/Possible Solution		Field Measurements/Component Compliance

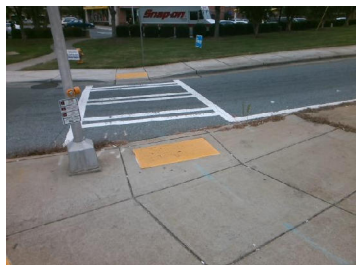
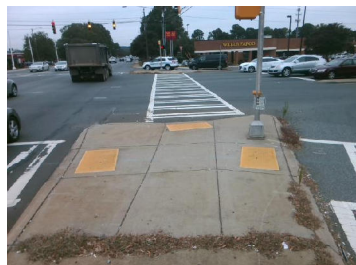
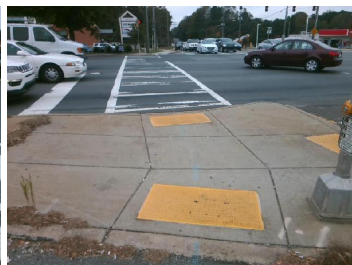
Compliance	Description	Data	Compliance	Description	Data
Yes	Refuge 1 Length (In)	52.0	N/A	Gutter 1 Ponding?	N/A
Yes	Refuge 1 Width (In)	60.0	N/A	Gutter 1 Lip Ht (In)	N/A
Yes	Refuge 1 Slope (%)	1.8	N/A	Gutter 1 Slope (%)	N/A
Yes	Refuge 1 X Slope (%)	4.2	N/A	Gutter 1 X Slope (%)	N/A
N/A	Painted X Walk1?	Yes	N/A	DWS 1 Provided?	N/A
N/A	X Walk 1 Direction	To SE	N/A	DWS 1 Contrast?	N/A
N/A	X Walk 1 Width (In)	110.0	N/A	DWS 1 Length (In)	N/A
N/A	Road 1 Slope (%)	3.2	N/A	DWS 1 Full Width?	N/A
N/A	Road 1 X Slope (%)	2.4	N/A	DWS 1 Offset (In)	N/A
Yes	Refuge 2 Length (In)	77.0	N/A	Gutter 2 Ponding?	N/A
No	Refuge 2 Width (In)	50.0	N/A	Gutter 2 Lip Ht (In)	N/A
Yes	Refuge 2 Slope (%)	2.8	N/A	Gutter 2 Slope (%)	N/A
Yes	Refuge 2 X Slope (%)	0.0	N/A	Gutter 2 X Slope (%)	N/A
N/A	Painted X Walk2?	Yes	N/A	DWS 2 Provided?	N/A
N/A	X Walk 2 Direction	To NW	N/A	DWS 2 Contrast?	N/A
N/A	X Walk 2 Width (In)	112.0	N/A	DWS 2 Length (In)	N/A

N/A	Road 2 Slope (%)	3.2	N/A	DWS 2 Full Width?	N/A
N/A	Road 2 X Slope (%)	1.2	N/A	DWS 2 Offset (In)	N/A
Yes	Refuge 3 Length (in)	52.0	N/A	Gutter 3 Ponding?	N/A
Yes	Refuge 3 Width (in)	60.0	N/A	Gutter 3 Lip Ht (in)	N/A
Yes	Refuge 3 Slope (%)	3.3	N/A	Gutter 3 Slope (%)	N/A
Yes	Refuge 3 XSlope (%)	1.3	N/A	Gutter 3 XSlope (%)	N/A
N/A	Painted X Walk3?	Yes	N/A	DWS 3 Provided?	N/A
N/A	X Walk 3 Direction	To SW	N/A	DWS 3 Contrast?	N/A
N/A	X Walk 3 Width (in)	107.0	N/A	DWS 3 Length (in)	N/A
N/A	Road 3 Slope (%)	2.3	N/A	DWS 3 Full Width?	N/A
N/A	Road 3 XSlope (%)	1.8	N/A	DWS 3 Offset (in)	N/A
Yes	Any Obstructions?	N/A	N/A	Storm Grate/Utility Hazard?	N/A
N/A	Obstruction Type		N/A	Storm Grate/Utility Type	
N/A	Surface Condition	Good	N/A		N/A

Possible Solutions:

Remove & Replace Entire Refuge.
