Access Compliance Report

Public Rights-of-Way

(Island Curb Cuts)

Intersection ID: 14648	Main Street: EAST_BV	Cross Street: LENNOX_AV	Location: SE
ADA ID: 4C849A22BE11	Curb Cut Type: MedianRefuge2	Initial Pass/Fail: Pass	Overall Compliance: No
Severity Score: 10.25			
Codes/Mitigation Info/Possible Solution		Field Measurements/Component Compliance

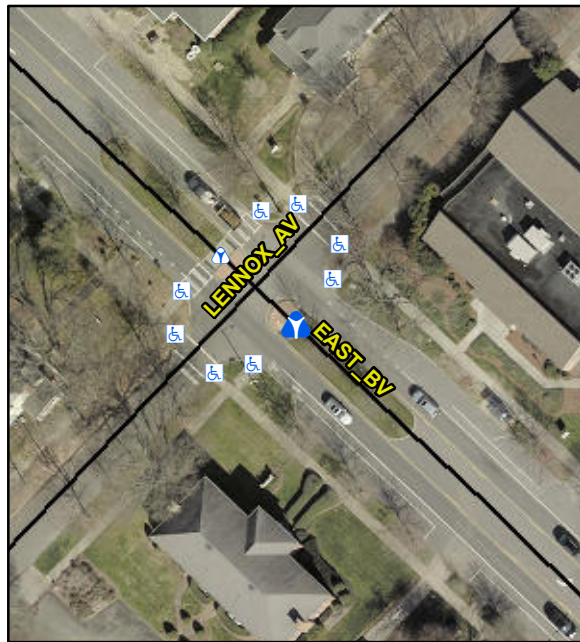
Compliance	Description	Data	Compliance	Description	Data
Yes	Refuge 1 Length (In)	114.5	Yes	Gutter 1 Ponding?	No
Yes	Refuge 1 Width (In)	97.0	Yes	Gutter 1 Lip Ht (In)	0.0
Yes	Refuge 1 Slope (%)	2.1	Yes	Gutter 1 Slope (%)	2.8
Yes	Refuge 1 X Slope (%)	0.9	Yes	Gutter 1 X Slope (%)	2.0
N/A	Painted X Walk1?	No	Yes	DWS 1 Provided?	Yes
N/A	X Walk 1 Direction	To SW	Yes	DWS 1 Contrast?	Yes
N/A	X Walk 1 Width (In)	N/A	Yes	DWS 1 Length (In)	24.5
N/A	Road 1 Slope (%)	1.7	Yes	DWS 1 Full Width?	Yes
N/A	Road 1 X Slope (%)	2.7	No	DWS 1 Offset (In)	7.0
Yes	Refuge 2 Length (In)	114.5	Yes	Gutter 2 Ponding?	No
Yes	Refuge 2 Width (In)	97.0	Yes	Gutter 2 Lip Ht (In)	0.0
Yes	Refuge 2 Slope (%)	3.8	No	Gutter 2 Slope (%)	7.3
Yes	Refuge 2 X Slope (%)	0.6	Yes	Gutter 2 X Slope (%)	1.5
N/A	Painted X Walk2?	No	Yes	DWS 2 Provided?	Yes
N/A	X Walk 2 Direction	To NE	Yes	DWS 2 Contrast?	Yes
N/A	X Walk 2 Width (In)	N/A	Yes	DWS 2 Length (In)	24.5

N/A	Road 2 Slope (%)	1.9	Yes	DWS 2 Full Width?	Yes
N/A	Road 2 X Slope (%)	3.0	No	DWS 2 Offset (In)	7.0
N/A	Refuge 3 Length (in)	N/A	N/A	Gutter 3 Ponding?	N/A
N/A	Refuge 3 Width (in)	N/A	N/A	Gutter 3 Lip Ht (in)	N/A
N/A	Refuge 3 Slope (%)	N/A	N/A	Gutter 3 Slope (%)	N/A
N/A	Refuge 3 XSlope (%)	N/A	N/A	Gutter 3 XSlope (%)	N/A
N/A	Painted X Walk3?	N/A	N/A	DWS 3 Provided?	N/A
N/A	X Walk 3 Direction	N/A	N/A	DWS 3 Contrast?	N/A
N/A	X Walk 3 Width (in)	N/A	N/A	DWS 3 Length (in)	N/A
N/A	Road 3 Slope (%)	N/A	N/A	DWS 3 Full Width?	N/A
N/A	Road 3 XSlope (%)	N/A	N/A	DWS 3 Offset (in)	N/A
Yes	Any Obstructions?	N/A	N/A	Storm Grate/Utility Hazard?	No
N/A	Obstruction Type		N/A	Storm Grate/Utility Type	
		N/A			N/A
N/A	Surface Condition	Good

Remove & Replace Detectable Warning System. Remove & Replace Gutter.
