Access Compliance Report

Public Rights-of-Way

(Island Curb Cuts)

Intersection ID: 3626	Main Street: LEXINGTON_APPROACH_DR	Cross Street: MALLARD_CREEK_RD	Location: E
ADA ID: 4D4390CE27C9	Curb Cut Type: MedianRefuge2	Initial Pass/Fail: Fail	Overall Compliance: No
Codes/Mitigation Info/Possible Solution		Field Measurements/Component Compliance	
Severity Score: 25

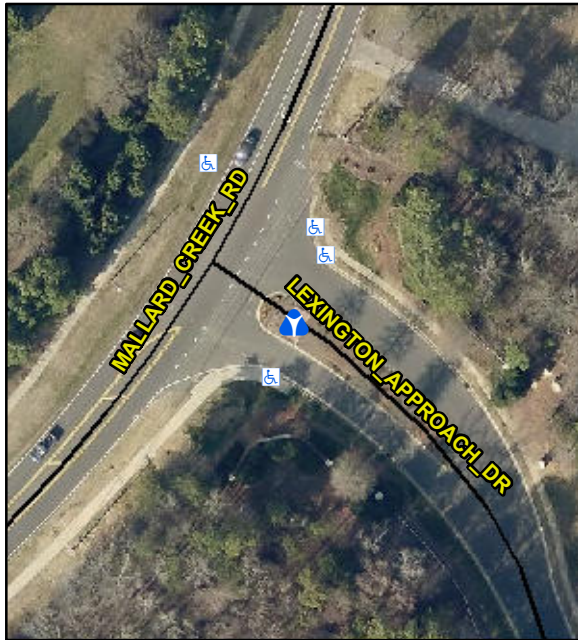
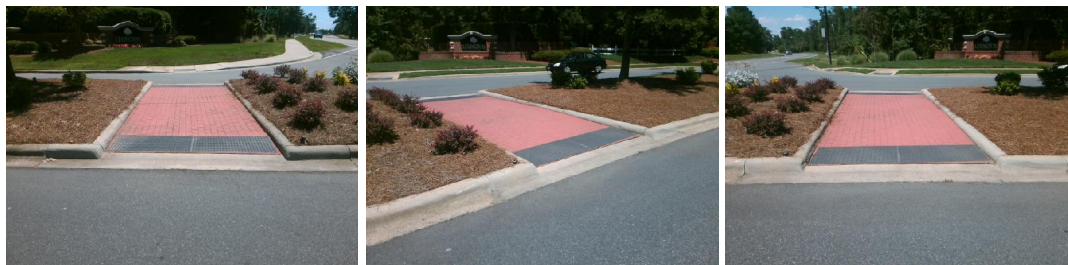
Compliance	Description	Data	Compliance	Description	Data
Yes	Refuge 1 Length (In)	113.0	N/A	Gutter 1 Ponding?	N/A
Yes	Refuge 1 Width (In)	96.0	N/A	Gutter 1 Lip Ht (In)	N/A
No	Refuge 1 Slope (%)	13.4	N/A	Gutter 1 Slope (%)	N/A
Yes	Refuge 1 X Slope (%)	2.2	N/A	Gutter 1 X Slope (%)	N/A
N/A	Painted X Walk1?	No	N/A	DWS 1 Provided?	N/A
N/A	X Walk 1 Direction	To NE	N/A	DWS 1 Contrast?	N/A
N/A	X Walk 1 Width (In)	N/A	N/A	DWS 1 Length (In)	N/A
N/A	Road 1 Slope (%)	2.3	N/A	DWS 1 Full Width?	N/A
N/A	Road 1 X Slope (%)	0.9	N/A	DWS 1 Offset (In)	N/A
Yes	Refuge 2 Length (In)	123.5	N/A	Gutter 2 Ponding?	N/A
Yes	Refuge 2 Width (In)	95.5	N/A	Gutter 2 Lip Ht (In)	N/A
No	Refuge 2 Slope (%)	10.8	N/A	Gutter 2 Slope (%)	N/A
Yes	Refuge 2 X Slope (%)	2.7	N/A	Gutter 2 X Slope (%)	N/A
N/A	Painted X Walk2?	No	N/A	DWS 2 Provided?	N/A
N/A	X Walk 2 Direction	To SW	N/A	DWS 2 Contrast?	N/A
N/A	X Walk 2 Width (In)	N/A	N/A	DWS 2 Length (In)	N/A

N/A	Road 2 Slope (%)	2.3	N/A	DWS 2 Full Width?	N/A
N/A	Road 2 X Slope (%)	2.7	N/A	DWS 2 Offset (In)	N/A
N/A	Refuge 3 Length (in)	N/A	N/A	Gutter 3 Ponding?	N/A
N/A	Refuge 3 Width (in)	N/A	N/A	Gutter 3 Lip Ht (in)	N/A
N/A	Refuge 3 Slope (%)	N/A	N/A	Gutter 3 Slope (%)	N/A
N/A	Refuge 3 XSlope (%)	N/A	N/A	Gutter 3 XSlope (%)	N/A
N/A	Painted X Walk3?	No	N/A	DWS 3 Provided?	N/A
N/A	X Walk 3 Direction	N/A	N/A	DWS 3 Contrast?	N/A
N/A	X Walk 3 Width (in)	N/A	N/A	DWS 3 Length (in)	N/A
N/A	Road 3 Slope (%)	N/A	N/A	DWS 3 Full Width?	N/A
N/A	Road 3 XSlope (%)	N/A	N/A	DWS 3 Offset (in)	N/A
Yes	Any Obstructions?	N/A	N/A	Storm Grate/Utility Hazard?	N/A
N/A	Obstruction Type		N/A	Storm Grate/Utility Type	
			N/A		N/A
N/A	Surface Condition	Good

Remove & Replace Entire Refuge.
