Access Compliance Report

Public Rights-of-Way

(Island Curb Cuts)

Intersection ID: 17513	Main Street: PROVIDENCE_DR	Cross Street: PROVIDENCE_RD	Location: S
ADA ID: 4F519499A252	Curb Cut Type: MedianRefuge2	Initial Pass/Fail: Fail	Overall Compliance: No
Severity Score: 10			
Codes/Mitigation Info/Possible Solution		Field Measurements/Component Compliance

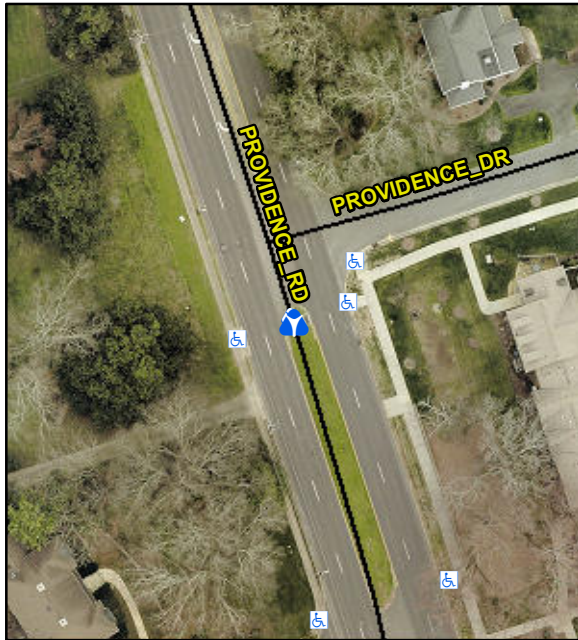
Compliance	Description	Data	Compliance	Description	Data
Yes	Refuge 1 Length (In)	80.0	N/A	Gutter 1 Ponding?	N/A
No	Refuge 1 Width (In)	59.0	N/A	Gutter 1 Lip Ht (In)	N/A
Yes	Refuge 1 Slope (%)	0.9	N/A	Gutter 1 Slope (%)	N/A
Yes	Refuge 1 X Slope (%)	3.6	N/A	Gutter 1 X Slope (%)	N/A
N/A	Painted X Walk1?	No	N/A	DWS 1 Provided?	N/A
N/A	X Walk 1 Direction	To E	N/A	DWS 1 Contrast?	N/A
N/A	X Walk 1 Width (In)	N/A	N/A	DWS 1 Length (In)	N/A
N/A	Road 1 Slope (%)	3.1	N/A	DWS 1 Full Width?	N/A
N/A	Road 1 X Slope (%)	1.7	N/A	DWS 1 Offset (In)	N/A
Yes	Refuge 2 Length (In)	80.0	N/A	Gutter 2 Ponding?	N/A
No	Refuge 2 Width (In)	59.0	N/A	Gutter 2 Lip Ht (In)	N/A
Yes	Refuge 2 Slope (%)	2.1	N/A	Gutter 2 Slope (%)	N/A
Yes	Refuge 2 X Slope (%)	4.3	N/A	Gutter 2 X Slope (%)	N/A
N/A	Painted X Walk2?	No	N/A	DWS 2 Provided?	N/A
N/A	X Walk 2 Direction	To W	N/A	DWS 2 Contrast?	N/A
N/A	X Walk 2 Width (In)	N/A	N/A	DWS 2 Length (In)	N/A

Remove & Replace Entire Refuge.
