Access Compliance Report

Public Rights-of-Way

(Island Curb Cuts)

Intersection ID: N/A	Main Street: N/A	Cross Street: N/A	Location:	W
ADA ID: 50273B70EC01	Curb Cut Type: MedianRefuge2	Initial Pass/Fail: Fail	Overall Compliance: No	Severity Score: 25
Codes/Mitigation Info/Possible Solution		Field Measurements/Component Compliance

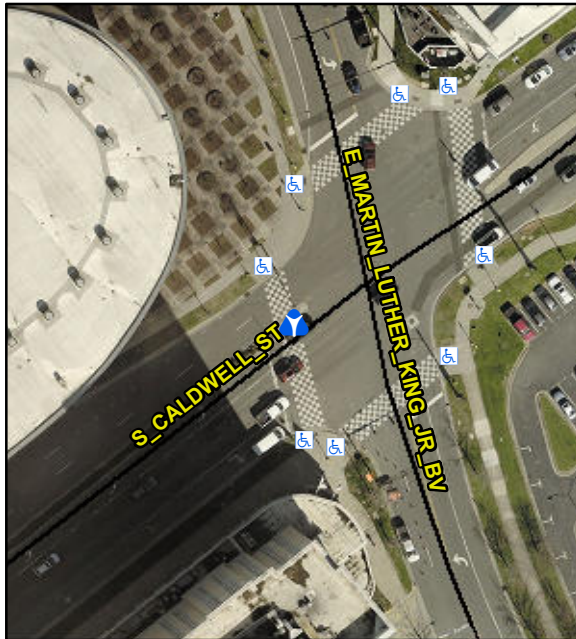
Compliance	Description	Data	Compliance	Description	Data
No	Refuge 1 Length (In)	15.0	N/A	Gutter 1 Ponding?	N/A
Yes	Refuge 1 Width (In)	181.0	N/A	Gutter 1 Lip Ht (In)	N/A
No	Refuge 1 Slope (%)	7.7	N/A	Gutter 1 Slope (%)	N/A
Yes	Refuge 1 X Slope (%)	0.6	N/A	Gutter 1 X Slope (%)	N/A
N/A	Painted X Walk1?	Yes	N/A	DWS 1 Provided?	N/A
N/A	X Walk 1 Direction	To S	N/A	DWS 1 Contrast?	N/A
N/A	X Walk 1 Width (In)	144.0	N/A	DWS 1 Length (In)	N/A
N/A	Road 1 Slope (%)	1.6	N/A	DWS 1 Full Width?	N/A
N/A	Road 1 X Slope (%)	0.6	N/A	DWS 1 Offset (In)	N/A
No	Refuge 2 Length (In)	15.0	N/A	Gutter 2 Ponding?	N/A
Yes	Refuge 2 Width (In)	181.0	N/A	Gutter 2 Lip Ht (In)	N/A
No	Refuge 2 Slope (%)	6.3	N/A	Gutter 2 Slope (%)	N/A
Yes	Refuge 2 X Slope (%)	0.0	N/A	Gutter 2 X Slope (%)	N/A
N/A	Painted X Walk2?	Yes	N/A	DWS 2 Provided?	N/A
N/A	X Walk 2 Direction	To N	N/A	DWS 2 Contrast?	N/A
N/A	X Walk 2 Width (In)	144.0	N/A	DWS 2 Length (In)	N/A

Remove & Replace Entire Refuge.
