# Access Compliance Report

## Public Rights-of-Way

### (Island Curb Cuts)

Intersection ID: 48168	Main Street: PERIMETER_PY	Cross Street: NORTHLAKE_MALL_DR	Location: SE
ADA ID: 514D1961EA6A	Curb Cut Type: IslandRefuge2	Initial Pass/Fail: Fail	Overall Compliance: No
Severity Score: 8.75			
Codes/Mitigation Info/Possible Solution		Field Measurements/Component Compliance

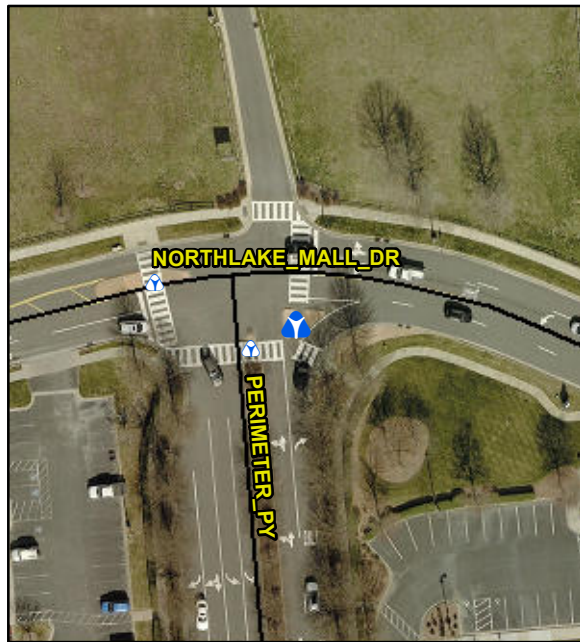
Compliance	Description	Data	Compliance	Description	Data
Yes	Refuge 1 Length (In)	88.0	N/A	Gutter 1 Ponding?	N/A
No	Refuge 1 Width (In)	52.0	N/A	Gutter 1 Lip Ht (In)	N/A
Yes	Refuge 1 Slope (%)	0.9	N/A	Gutter 1 Slope (%)	N/A
Yes	Refuge 1 X Slope (%)	2.3	N/A	Gutter 1 X Slope (%)	N/A
N/A	Painted X Walk1?	Yes	N/A	DWS 1 Provided?	N/A
N/A	X Walk 1 Direction	To N	N/A	DWS 1 Contrast?	N/A
N/A	X Walk 1 Width (In)	101.0	N/A	DWS 1 Length (In)	N/A
N/A	Road 1 Slope (%)	2.2	N/A	DWS 1 Full Width?	N/A
N/A	Road 1 X Slope (%)	3.2	N/A	DWS 1 Offset (In)	N/A
Yes	Refuge 2 Length (In)	88.0	N/A	Gutter 2 Ponding?	N/A
No	Refuge 2 Width (In)	52.0	N/A	Gutter 2 Lip Ht (In)	N/A
Yes	Refuge 2 Slope (%)	1.9	N/A	Gutter 2 Slope (%)	N/A
Yes	Refuge 2 X Slope (%)	1.1	N/A	Gutter 2 X Slope (%)	N/A
N/A	Painted X Walk2?	Yes	N/A	DWS 2 Provided?	N/A
N/A	X Walk 2 Direction	To S	N/A	DWS 2 Contrast?	N/A
N/A	X Walk 2 Width (In)	100.0	N/A	DWS 2 Length (In)	N/A

**Remove & Replace Entire Refuge.**
