Access Compliance Report

Public Rights-of-Way

(Island Curb Cuts)

Intersection ID: 10023892	Main Street: COMMUNITY_HOUSE_RD	Cross Street: N/A	Location: N
ADA ID: 51A3918AD8B7	Curb Cut Type: MedianRefuge2	Initial Pass/Fail: Fail	Overall Compliance: No
Codes/Mitigation Info/Possible Solution		Field Measurements/Component Compliance

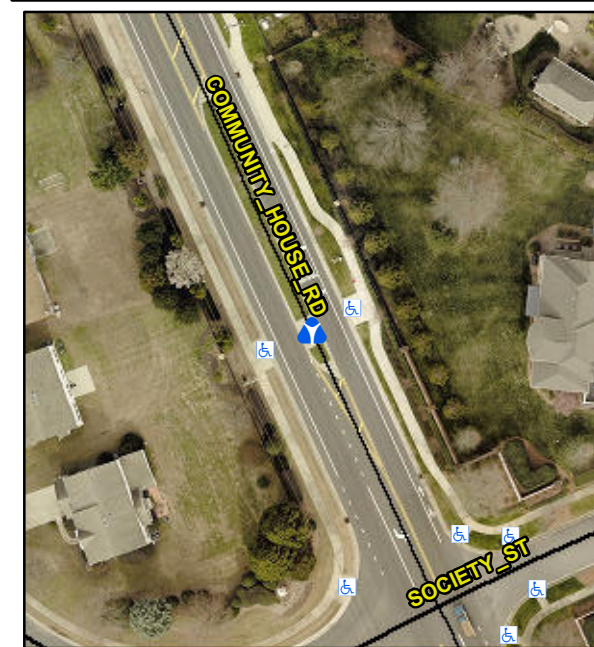
Compliance	Description	Data	Compliance	Description	Data
Yes	Refuge 1 Length (In)	54.0	N/A	Gutter 1 Ponding?	N/A
No	Refuge 1 Width (In)	47.0	N/A	Gutter 1 Lip Ht (In)	N/A
Yes	Refuge 1 Slope (%)	1.8	N/A	Gutter 1 Slope (%)	N/A
Yes	Refuge 1 X Slope (%)	1.7	N/A	Gutter 1 X Slope (%)	N/A
N/A	Painted X Walk1?	No	N/A	DWS 1 Provided?	N/A
N/A	X Walk 1 Direction	To NE	N/A	DWS 1 Contrast?	N/A
N/A	X Walk 1 Width (In)	N/A	N/A	DWS 1 Length (In)	N/A
N/A	Road 1 Slope (%)	1.6	N/A	DWS 1 Full Width?	N/A
N/A	Road 1 X Slope (%)	4.8	N/A	DWS 1 Offset (In)	N/A
Yes	Refuge 2 Length (In)	54.0	N/A	Gutter 2 Ponding?	N/A
No	Refuge 2 Width (In)	47.0	N/A	Gutter 2 Lip Ht (In)	N/A
Yes	Refuge 2 Slope (%)	2.6	N/A	Gutter 2 Slope (%)	N/A
Yes	Refuge 2 X Slope (%)	2.5	N/A	Gutter 2 X Slope (%)	N/A
N/A	Painted X Walk2?	No	N/A	DWS 2 Provided?	N/A
N/A	X Walk 2 Direction	To SW	N/A	DWS 2 Contrast?	N/A
N/A	X Walk 2 Width (In)	N/A	N/A	DWS 2 Length (In)	N/A

Possible Solutions:

Remove & Replace Entire Refuge.
