## Access Compliance Report Public Rights-of-Way (Island Curb Cuts)

Intersection ID: 9068Main Street: W\_TRADE\_STCross Street: ROZZELLES\_FERRY\_RDLocation:NADA ID: 524D7476E32DCurb Cut Type: IslandRefuge3Initial Pass/Fail: FailOverall Compliance: NoSeverity Score:60

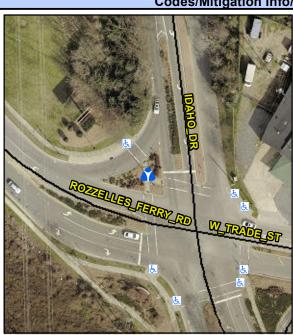
No	Refuge 3 XSlope (%)	7.4 N/A	Gutter 3 XSlope (%)	N/A
N/A	Painted X Walk3?	Yes N/A	DWS 3 Provided?	N/A
N/A	X Walk 3 Direction	To N N/A	DWS 3 Contrast?	N/A
N/A	X Walk 3 Width (in)	110.0 N/A	DWS 3 Length (in)	N/A
N/A	Road 3 Slope (%)	7.3 N/A	DWS 3 Full Width?	N/A
N/A	Road 3 XSlope (%)	1.4 N/A	DWS 3 Offset (in)	N/A
Yes	Any Obstructions?	N/A N/A	Storm Grate/Utility Hazard?	N/A
N/A	Obstruction Type	N/A	Storm Grate/Utility Type	
		N/A		N/A
N/A	Surface Condition	Good

Remove & Replace Entire Refuge.
