Access Compliance Report Public Rights-of-Way (Island Curb Cuts)

Intersection ID: 11695 Main Street: PARKWOOD_AV Cross Street: THE_PLAZA Location: W

ADA ID: 524E89AC676B Curb Cut Type: MedianRefuge2 Initial Pass/Fail: Pass Overall Compliance: No Severity Score: 22.75

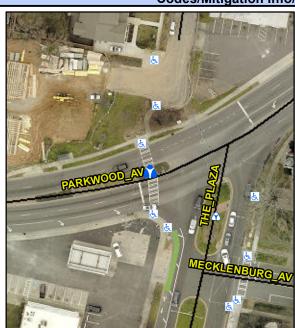
Com	pliance	Description	Data	Com	pliance	Descrip
Yes	Refuge	1 Length (In)	72.0	Yes	Gutter 1	Ponding?
Yes	Refuge	1 Width (In)	94.0	No	Gutter 1	Lip Ht (In)
Yes	Refuge	1 Slope (%)	3.3	No	Gutter 1	Slope (%)
Yes	Refuge	1 X Slope (%)	0.4	Yes	Gutter 1	X Slope (
N/A	Painted	X Walk1?	Yes	Yes	DWS 1	Provided?
N/A	X Walk	1 Direction	To S	Yes	DWS 1	Contrast?
N/A	X Walk	1 Width (In)	110.5	Yes	DWS 1	Length (In)
N/A	Road 1	Slope (%)	1.0	No	DWS 1	Full Width?
N/A	Road 1	X Slope (%)	5.3	No	DWS 1	Offset (In)
Yes	Refuge	2 Length (In)	72.0	Yes	Gutter 2	Ponding?
Yes	Refuge	2 Width (In)	94.0	No	Gutter 2	Lip Ht (In)
Yes	Refuge	2 Slope (%)	0.7	Yes	Gutter 2	Slope (%)
Yes	Refuge	2 X Slope (%)	0.7	Yes	Gutter 2	X Slope (
N/A	Painted	X Walk2?	Yes	Yes	DWS 2	Provided?
N/A	X Walk	2 Direction	To N	Yes	DWS 2	Contrast?
N/A	X Walk	2 Width (In)	109.0	Yes	DWS 2	Length (In)
N/A	Road 2	Slope (%)	0.1	No	DWS 2	Full Width?
N/A	Road 2	X Slope (%)	5.0	No	DWS 2	Offset (In)

Remove & Replace Detectable Warning System. Grind Gutter Lip. Remove & Replace Gutter.
