Access Compliance Report

Public Rights-of-Way

(Island Curb Cuts)

Intersection ID: 27610	Main Street: JOHNSTON_RD	Cross Street: JOHN_J_DELANEY_DR	Location: NW
ADA ID: 5311B9D4D82A	Curb Cut Type: MedianRefuge2	Initial Pass/Fail: Fail	Overall Compliance: No
Codes/Mitigation Info/Possible Solution		Field Measurements/Component Compliance	
Severity Score: 1.25

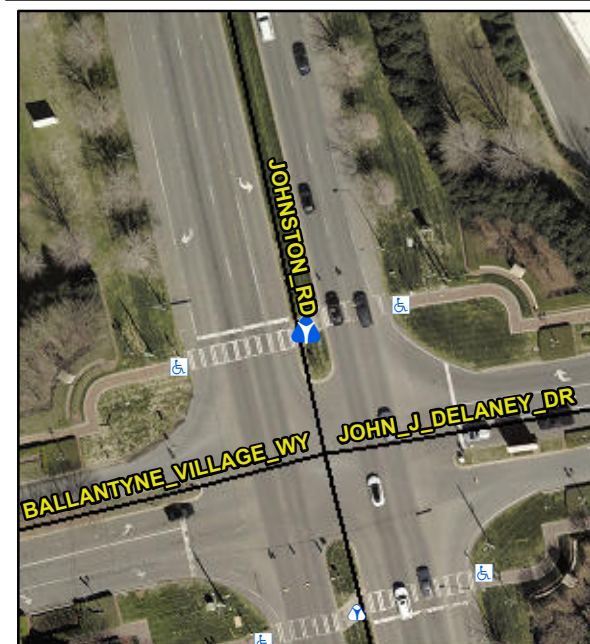
Compliance	Description	Data	Compliance	Description	Data
Yes	Refuge 1 Length (In)	97.0	N/A	Gutter 1 Ponding?	N/A
Yes	Refuge 1 Width (In)	127.0	N/A	Gutter 1 Lip Ht (In)	N/A
Yes	Refuge 1 Slope (%)	3.7	N/A	Gutter 1 Slope (%)	N/A
Yes	Refuge 1 X Slope (%)	0.9	N/A	Gutter 1 X Slope (%)	N/A
N/A	Painted X Walk1?	Yes	N/A	DWS 1 Provided?	N/A
N/A	X Walk 1 Direction	To SW	N/A	DWS 1 Contrast?	N/A
N/A	X Walk 1 Width (In)	108.0	N/A	DWS 1 Length (In)	N/A
N/A	Road 1 Slope (%)	1.8	N/A	DWS 1 Full Width?	N/A
N/A	Road 1 X Slope (%)	3.6	N/A	DWS 1 Offset (In)	N/A
Yes	Refuge 2 Length (In)	97.0	N/A	Gutter 2 Ponding?	N/A
Yes	Refuge 2 Width (In)	127.0	N/A	Gutter 2 Lip Ht (In)	N/A
Yes	Refuge 2 Slope (%)	2.2	N/A	Gutter 2 Slope (%)	N/A
Yes	Refuge 2 X Slope (%)	2.9	N/A	Gutter 2 X Slope (%)	N/A
N/A	Painted X Walk2?	Yes	N/A	DWS 2 Provided?	N/A
N/A	X Walk 2 Direction	To NE	N/A	DWS 2 Contrast?	N/A
N/A	X Walk 2 Width (In)	109.0	N/A	DWS 2 Length (In)	N/A

N/A	Road 2 Slope (%)	2.9	N/A	DWS 2 Full Width?	N/A
N/A	Road 2 X Slope (%)	4.9	N/A	DWS 2 Offset (In)	N/A
N/A	Refuge 3 Length (in)	N/A	N/A	Gutter 3 Ponding?	N/A
N/A	Refuge 3 Width (in)	N/A	N/A	Gutter 3 Lip Ht (in)	N/A
N/A	Refuge 3 Slope (%)	N/A	N/A	Gutter 3 Slope (%)	N/A
N/A	Refuge 3 XSlope (%)	N/A	N/A	Gutter 3 XSlope (%)	N/A
N/A	Painted X Walk3?	N/A	N/A	DWS 3 Provided?	N/A
N/A	X Walk 3 Direction	N/A	N/A	DWS 3 Contrast?	N/A
N/A	X Walk 3 Width (in)	N/A	N/A	DWS 3 Length (in)	N/A
N/A	Road 3 Slope (%)	N/A	N/A	DWS 3 Full Width?	N/A
N/A	Road 3 XSlope (%)	N/A	N/A	DWS 3 Offset (in)	N/A
Yes	Any Obstructions?	N/A	N/A	Storm Grate/Utility Hazard?	N/A
N/A	Obstruction Type		N/A	Storm Grate/Utility Type	
		N/A			N/A
N/A	Surface Condition	Good

Remove & Replace Entire Refuge.

\$ 3000.00
