Access Compliance Report

Public Rights-of-Way

(Island Curb Cuts)

Intersection ID: 53534	Main Street: N_JOSH_BIRMINGHAM_PY	Cross Street: WILKINSON_BV	Location: NW
ADA ID: 53AAFA15ECE9	Curb Cut Type: IslandRefuge3	Initial Pass/Fail: Fail	Overall Compliance: No
		Severity Score: 36.25

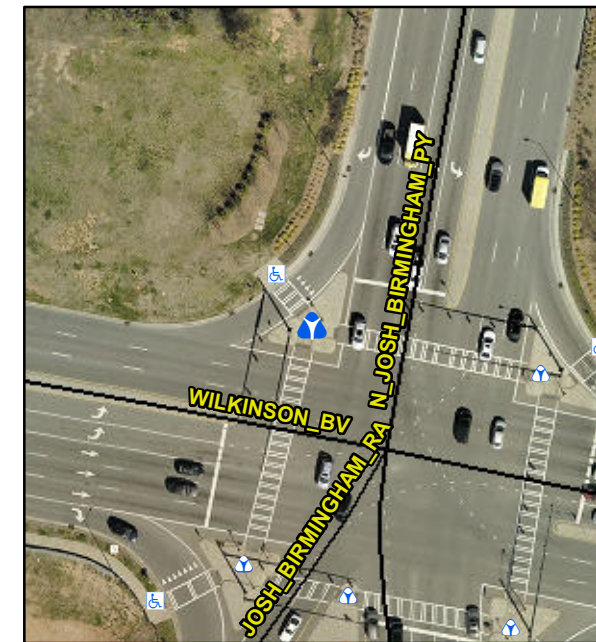
Compliance	Description	Data	Compliance	Description	Data
Yes	Refuge 1 Length (In)	117.0	N/A	Gutter 1 Ponding?	N/A
Yes	Refuge 1 Width (In)	72.0	N/A	Gutter 1 Lip Ht (In)	N/A
Yes	Refuge 1 Slope (%)	0.7	N/A	Gutter 1 Slope (%)	N/A
Yes	Refuge 1 X Slope (%)	2.5	N/A	Gutter 1 X Slope (%)	N/A
N/A	Painted X Walk1?	Yes	N/A	DWS 1 Provided?	N/A
N/A	X Walk 1 Direction	To E	N/A	DWS 1 Contrast?	N/A
N/A	X Walk 1 Width (In)	111.0	N/A	DWS 1 Length (In)	N/A
N/A	Road 1 Slope (%)	1.3	N/A	DWS 1 Full Width?	N/A
N/A	Road 1 X Slope (%)	0.9	N/A	DWS 1 Offset (In)	N/A
Yes	Refuge 2 Length (In)	47.0	N/A	Gutter 2 Ponding?	N/A
Yes	Refuge 2 Width (In)	90.0	N/A	Gutter 2 Lip Ht (In)	N/A
Yes	Refuge 2 Slope (%)	1.0	N/A	Gutter 2 Slope (%)	N/A
Yes	Refuge 2 X Slope (%)	1.7	N/A	Gutter 2 X Slope (%)	N/A
N/A	Painted X Walk2?	Yes	N/A	DWS 2 Provided?	N/A
N/A	X Walk 2 Direction	To W	N/A	DWS 2 Contrast?	N/A
N/A	X Walk 2 Width (In)	111.0	N/A	DWS 2 Length (In)	N/A

N/A	Road 2 Slope (%)	0.3	N/A	DWS 2 Full Width?	N/A
N/A	Road 2 X Slope (%)	3.7	N/A	DWS 2 Offset (In)	N/A
Yes	Refuge 3 Length (in)	95.0	N/A	Gutter 3 Ponding?	N/A
Yes	Refuge 3 Width (in)	95.0	N/A	Gutter 3 Lip Ht (in)	N/A
Yes	Refuge 3 Slope (%)	3.9	N/A	Gutter 3 Slope (%)	N/A
Yes	Refuge 3 XSlope (%)	0.1	N/A	Gutter 3 XSlope (%)	N/A
N/A	Painted X Walk3?	Yes	N/A	DWS 3 Provided?	N/A
N/A	X Walk 3 Direction	To S	N/A	DWS 3 Contrast?	N/A
N/A	X Walk 3 Width (in)	111.0	N/A	DWS 3 Length (in)	N/A
N/A	Road 3 Slope (%)	0.2	N/A	DWS 3 Full Width?	N/A
N/A	Road 3 XSlope (%)	1.9	N/A	DWS 3 Offset (in)	N/A
Yes	Any Obstructions?	N/A	N/A	Storm Grate/Utility Hazard?	N/A
N/A	Obstruction Type		N/A	Storm Grate/Utility Type	
		N/A			N/A
N/A	Surface Condition	Good

Possible Solutions:

Remove & Replace Entire Refuge.

Total Cost: \$ 3000.00
