# Access Compliance Report

## Public Rights-of-Way

| Intersection ID: 18050 | Main Street: S_TRYON_ST | Cross Street: SOUTHAMPTON_RD | Location: E |
| ADA ID: 54212FC9611A | Curb Cut Type: MedianRefuge2 | Initial Pass/Fail: Pass | Overall Compliance: No |

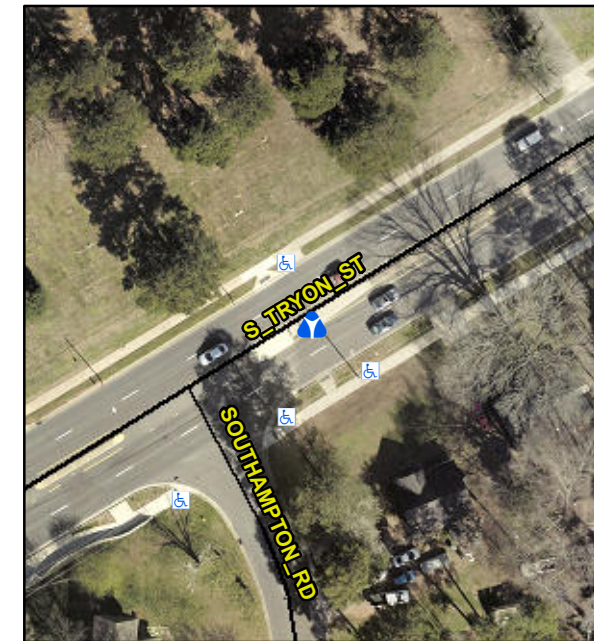
| Compliance | Description | Data | Compliance | Description | Data |
|---|---|---|---|---|---|
| Yes | Refuge 1 Slope (%) | 0.6 | No | Gutter 1 Slope (%) | N/A |
| Yes | Refuge 1 X Slope (%) | 1.8 | No | Gutter 1 X Slope (%) | N/A |
| Yes | Refuge 2 Slope (%) | 0.5 | No | Gutter 2 Slope (%) | N/A |
| Yes | Refuge 2 X Slope (%) | 1.2 | No | Gutter 2 X Slope (%) | N/A |

**Remove & Replace Gutter.**

Total Cost: \$ 1500.00
