Access Compliance Report

Public Rights-of-Way

(Island Curb Cuts)

Intersection ID: 10020719	Main Street: BEATTIES_FORD_RD	Cross Street: N/A	Location: N
ADA ID: 542C98C72BCF	Curb Cut Type: MedianRefuge2	Initial Pass/Fail: Pass	Overall Compliance: No
Codes/Mitigation Info/Possible Solution		Field Measurements/Component Compliance

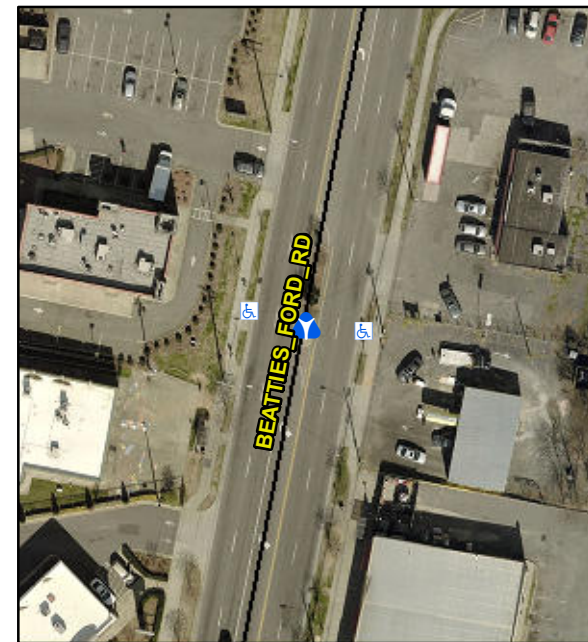
Compliance	Description	Data	Compliance	Description	Data
Yes	Refuge 1 Length (In)	54.5	Yes	Gutter 1 Ponding?	No
Yes	Refuge 1 Width (In)	71.5	Yes	Gutter 1 Lip Ht (In)	0.0
Yes	Refuge 1 Slope (%)	3.4	Yes	Gutter 1 Slope (%)	4.1
Yes	Refuge 1 X Slope (%)	0.6	Yes	Gutter 1 X Slope (%)	0.7
N/A	Painted X Walk1?	No	Yes	DWS 1 Provided?	Yes
N/A	X Walk 1 Direction	To W	Yes	DWS 1 Contrast?	Yes
N/A	X Walk 1 Width (In)	N/A	Yes	DWS 1 Length (In)	24.0
N/A	Road 1 Slope (%)	0.9	Yes	DWS 1 Full Width?	Yes
N/A	Road 1 X Slope (%)	2.6	No	DWS 1 Offset (In)	7.0
Yes	Refuge 2 Length (In)	54.5	Yes	Gutter 2 Ponding?	N/A
Yes	Refuge 2 Width (In)	71.5	Yes	Gutter 2 Lip Ht (In)	0.0
Yes	Refuge 2 Slope (%)	2.9	Yes	Gutter 2 Slope (%)	1.2
Yes	Refuge 2 X Slope (%)	1.1	Yes	Gutter 2 X Slope (%)	0.3
N/A	Painted X Walk2?	No	Yes	DWS 2 Provided?	Yes
N/A	X Walk 2 Direction	To E	Yes	DWS 2 Contrast?	Yes
N/A	X Walk 2 Width (In)	N/A	Yes	DWS 2 Length (In)	24.0

N/A	Road 2 Slope (%)	0.1	Yes	DWS 2 Full Width?	Yes
N/A	Road 2 X Slope (%)	3.8	No	DWS 2 Offset (In)	7.0
N/A	Refuge 3 Length (in)	N/A	N/A	Gutter 3 Ponding?	N/A
N/A	Refuge 3 Width (in)	N/A	N/A	Gutter 3 Lip Ht (in)	N/A
N/A	Refuge 3 Slope (%)	N/A	N/A	Gutter 3 Slope (%)	N/A
N/A	Refuge 3 XSlope (%)	N/A	N/A	Gutter 3 XSlope (%)	N/A
N/A	Painted X Walk3?	N/A	N/A	DWS 3 Provided?	N/A
N/A	X Walk 3 Direction	N/A	N/A	DWS 3 Contrast?	N/A
N/A	X Walk 3 Width (in)	N/A	N/A	DWS 3 Length (in)	N/A
N/A	Road 3 Slope (%)	N/A	N/A	DWS 3 Full Width?	N/A
N/A	Road 3 XSlope (%)	N/A	N/A	DWS 3 Offset (in)	N/A
Yes	Any Obstructions?	No	N/A	Storm Grate/Utility Hazard?	No
N/A	Obstruction Type		N/A	Storm Grate/Utility Type	
		N/A			N/A
N/A	Surface Condition	Good

Remove & Replace Detectable Warning System.
