Access Compliance Report

Public Rights-of-Way

(Island Curb Cuts)

Intersection ID: 7770	Main Street: E_ARROWHEAD_DR	Cross Street: N_TRYON_ST	Location:	S
ADA ID: 548F67DDC6D8	Curb Cut Type: MedianRefuge2	Initial Pass/Fail: Pass	Overall Compliance: No	Severity Score: 15

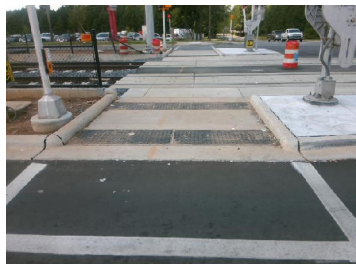
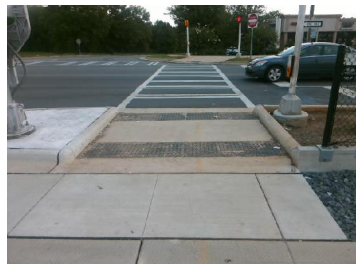
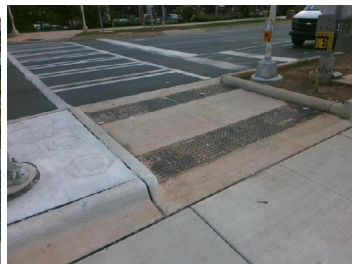
Compliance	Description	Data	Compliance	Description	Data
Yes	Refuge 1 Length (In)	48.0	Yes	Gutter 1 Ponding?	No
Yes	Refuge 1 Width (In)	121.0	No	Gutter 1 Lip Ht (In)	0.75
Yes	Refuge 1 Slope (%)	0.4	Yes	Gutter 1 Slope (%)	0.7
Yes	Refuge 1 X Slope (%)	0.1	Yes	Gutter 1 X Slope (%)	0.4
N/A	Painted X Walk1?	Yes	Yes	DWS 1 Provided?	Yes
N/A	X Walk 1 Direction	To E	Yes	DWS 1 Contrast?	Yes
N/A	X Walk 1 Width (In)	122.0	Yes	DWS 1 Length (In)	24.0
N/A	Road 1 Slope (%)	0.0	Yes	DWS 1 Full Width?	Yes
N/A	Road 1 X Slope (%)	1.6	Yes	DWS 1 Offset (In)	1.0
Yes	Refuge 2 Length (In)	48.0	Yes	Gutter 2 Ponding?	No
Yes	Refuge 2 Width (In)	121.0	Yes	Gutter 2 Lip Ht (In)	0.0
Yes	Refuge 2 Slope (%)	0.5	Yes	Gutter 2 Slope (%)	0.9
Yes	Refuge 2 X Slope (%)	0.6	Yes	Gutter 2 X Slope (%)	0.1
N/A	Painted X Walk2?	No	Yes	DWS 2 Provided?	Yes
N/A	X Walk 2 Direction	To W	Yes	DWS 2 Contrast?	Yes
N/A	X Walk 2 Width (In)	N/A	Yes	DWS 2 Length (In)	24.0

Grind Gutter Lip.
