Access Compliance Report

Public Rights-of-Way

(Island Curb Cuts)

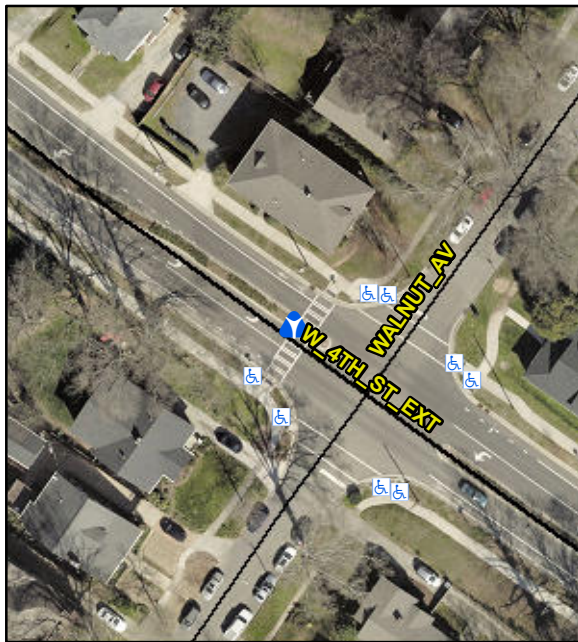
Intersection ID: 11231	Main Street: W_4TH_ST_EXT	Cross Street: WALNUT_AV	Location: NW
ADA ID: 58E98E757CC1	Curb Cut Type: MedianRefuge2	Initial Pass/Fail: Fail	Overall Compliance: No
Severity Score: 1.25			
Codes/Mitigation Info/Possible Solution		Field Measurements/Component Compliance

Possible Solutions:

Remove & Replace Entire Refuge.
