Access Compliance Report

Public Rights-of-Way

(Island Curb Cuts)

Intersection ID: 10795	Main Street: CLEMSON_AV	Cross Street: MATHESON_AV	Location: SE
ADA ID: 59103833678B	Curb Cut Type: MedianRefuge2	Initial Pass/Fail: Fail	Overall Compliance: No
Codes/Mitigation Info/Possible Solution		Field Measurements/Component Compliance	
Severity Score: 8.75

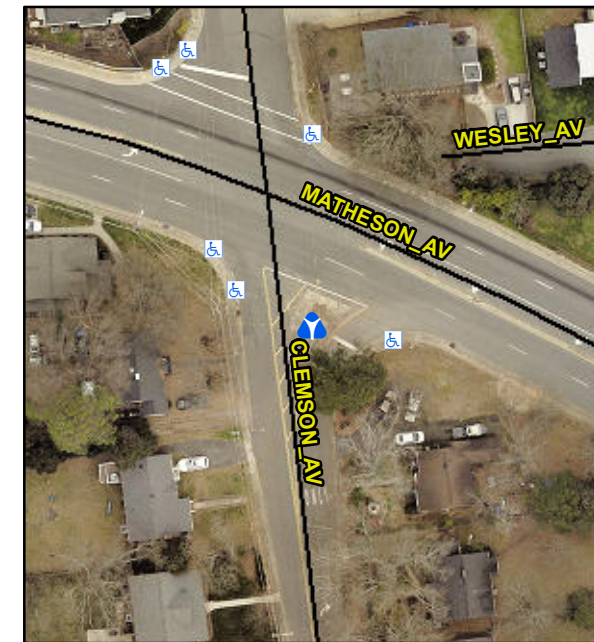
Compliance	Description	Data	Compliance	Description	Data
Yes	Refuge 1 Length (In)	123.0	N/A	Gutter 1 Ponding?	N/A
No	Refuge 1 Width (In)	59.5	N/A	Gutter 1 Lip Ht (In)	N/A
Yes	Refuge 1 Slope (%)	1.8	N/A	Gutter 1 Slope (%)	N/A
Yes	Refuge 1 X Slope (%)	0.6	N/A	Gutter 1 X Slope (%)	N/A
N/A	Painted X Walk1?	No	N/A	DWS 1 Provided?	N/A
N/A	X Walk 1 Direction	To NW	N/A	DWS 1 Contrast?	N/A
N/A	X Walk 1 Width (In)	N/A	N/A	DWS 1 Length (In)	N/A
N/A	Road 1 Slope (%)	0.6	N/A	DWS 1 Full Width?	N/A
N/A	Road 1 X Slope (%)	2.7	N/A	DWS 1 Offset (In)	N/A
Yes	Refuge 2 Length (In)	123.0	N/A	Gutter 2 Ponding?	N/A
No	Refuge 2 Width (In)	59.5	N/A	Gutter 2 Lip Ht (In)	N/A
Yes	Refuge 2 Slope (%)	1.1	N/A	Gutter 2 Slope (%)	N/A
Yes	Refuge 2 X Slope (%)	1.6	N/A	Gutter 2 X Slope (%)	N/A
N/A	Painted X Walk2?	No	N/A	DWS 2 Provided?	N/A
N/A	X Walk 2 Direction	To SE	N/A	DWS 2 Contrast?	N/A
N/A	X Walk 2 Width (In)	N/A	N/A	DWS 2 Length (In)	N/A

N/A	Road 2 Slope (%)	3.0	N/A	DWS 2 Full Width?	N/A
N/A	Road 2 X Slope (%)	1.1	N/A	DWS 2 Offset (In)	N/A
N/A	Refuge 3 Length (in)	N/A	N/A	Gutter 3 Ponding?	N/A
N/A	Refuge 3 Width (in)	N/A	N/A	Gutter 3 Lip Ht (in)	N/A
N/A	Refuge 3 Slope (%)	N/A	N/A	Gutter 3 Slope (%)	N/A
N/A	Refuge 3 XSlope (%)	N/A	N/A	Gutter 3 XSlope (%)	N/A
N/A	Painted X Walk3?	N/A	N/A	DWS 3 Provided?	N/A
N/A	X Walk 3 Direction	N/A	N/A	DWS 3 Contrast?	N/A
N/A	X Walk 3 Width (in)	N/A	N/A	DWS 3 Length (in)	N/A
N/A	Road 3 Slope (%)	N/A	N/A	DWS 3 Full Width?	N/A
N/A	Road 3 XSlope (%)	N/A	N/A	DWS 3 Offset (in)	N/A
Yes	Any Obstructions?	N/A	N/A	Storm Grate/Utility Hazard?	N/A
N/A	Obstruction Type		N/A	Storm Grate/Utility Type	
		N/A			N/A
N/A	Surface Condition	Good

Possible Solutions:

Remove & Replace Entire Refuge.
