Access Compliance Report

Public Rights-of-Way

(Island Curb Cuts)

| Intersection ID: 6957 | Main Street: N_TRYON_ST | Cross Street: N_US_29_BY-PASS_HY | Location: N |

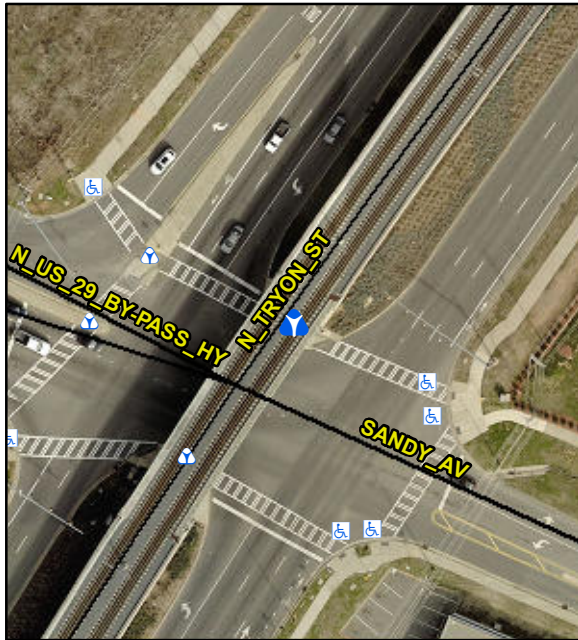
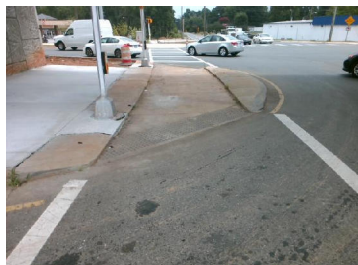
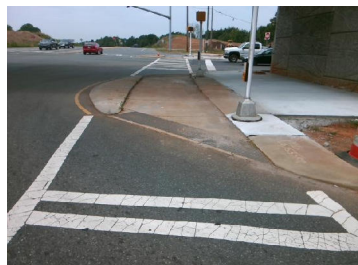
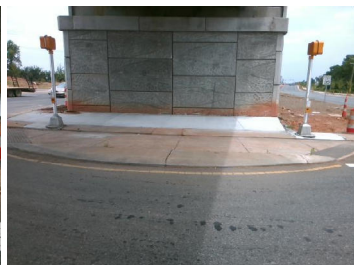
| ADA ID: 59D952D9EA87 | Curb Cut Type: MedianRefuge2 | Initial Pass/Fail: Fail | Overall Compliance: No |
| Severity Score: 1.25 | | | |

Remove & Replace Entire Refuge.

Total Cost: \$ 3000.00
