Access Compliance Report

Public Rights-of-Way

(Island Curb Cuts)

Intersection ID: 5296	Main Street: GROVE LAKE DR	Cross Street: N TRYON ST	Location: NW
ADA ID: 5A4CF0925A12	Curb Cut Type: MedianRefuge2	Initial Pass/Fail: Fail	Overall Compliance: No
Severity Score: 0			
Codes/Mitigation Info/Possible Solution		Field Measurements/Component Compliance

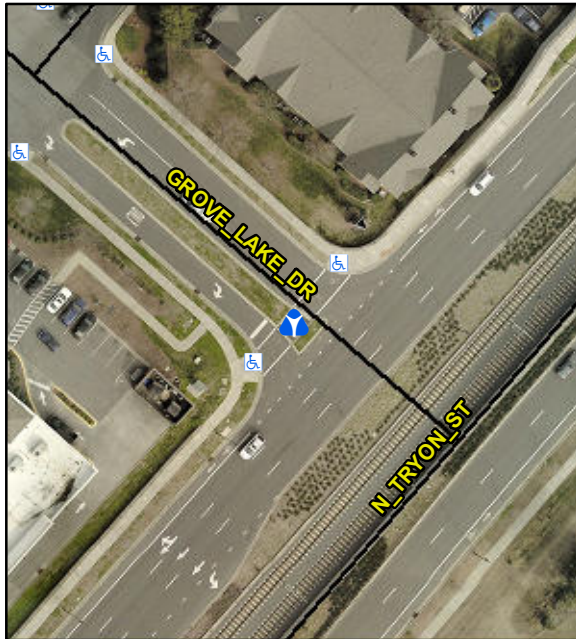
Compliance	Description	Data	Compliance	Description	Data
Yes	Refuge 1 Length (In)	65.0	N/A	Gutter 1 Ponding?	N/A
Yes	Refuge 1 Width (In)	90.0	N/A	Gutter 1 Lip Ht (In)	N/A
Yes	Refuge 1 Slope (%)	0.2	N/A	Gutter 1 Slope (%)	N/A
Yes	Refuge 1 X Slope (%)	3.9	N/A	Gutter 1 X Slope (%)	N/A
N/A	Painted X Walk1?	Yes	N/A	DWS 1 Provided?	N/A
N/A	X Walk 1 Direction	To NE	N/A	DWS 1 Contrast?	N/A
N/A	X Walk 1 Width (In)	90.0	N/A	DWS 1 Length (In)	N/A
N/A	Road 1 Slope (%)	3.0	N/A	DWS 1 Full Width?	N/A
N/A	Road 1 X Slope (%)	6.2	N/A	DWS 1 Offset (In)	N/A
Yes	Refuge 2 Length (In)	95.0	N/A	Gutter 2 Ponding?	N/A
Yes	Refuge 2 Width (In)	90.0	N/A	Gutter 2 Lip Ht (In)	N/A
Yes	Refuge 2 Slope (%)	1.4	N/A	Gutter 2 Slope (%)	N/A
Yes	Refuge 2 X Slope (%)	3.2	N/A	Gutter 2 X Slope (%)	N/A
N/A	Painted X Walk2?	Yes	N/A	DWS 2 Provided?	N/A
N/A	X Walk 2 Direction	To SE	N/A	DWS 2 Contrast?	N/A
N/A	X Walk 2 Width (In)	90.0	N/A	DWS 2 Length (In)	N/A

Remove & Replace Entire Refuge.

\$ 3000.00
