# Access Compliance Report

## Public Rights-of-Way

### (Island Curb Cuts)

Intersection ID: 5600	Main Street: N_TRYON_ST	Cross Street: J_M_KEYNES_DR	Location: NE
ADA ID: 5ABE23763669	Curb Cut Type: MedianRefuge2	Initial Pass/Fail: Pass	Overall Compliance: No
Severity Score: 0			
Codes/Mitigation Info/Possible Solution		Field Measurements/Component Compliance

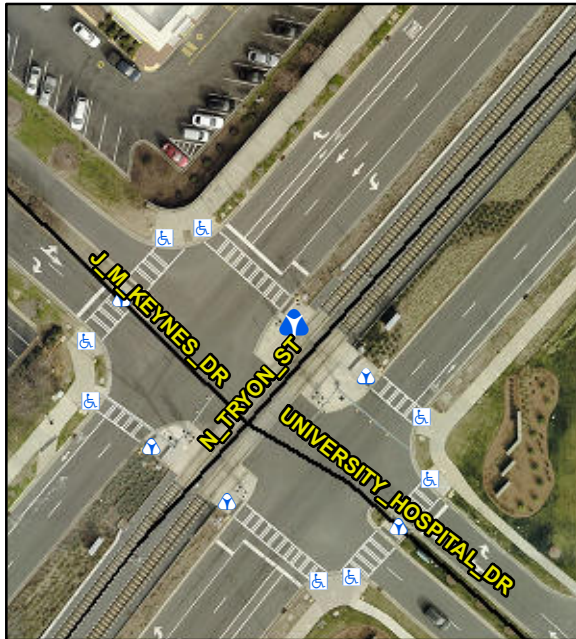
Compliance	Description	Data	Compliance	Description	Data
Yes	Refuge 1 Length (In)	48.0	Yes	Gutter 1 Ponding?	No
Yes	Refuge 1 Width (In)	120.0	Yes	Gutter 1 Lip Ht (In)	0.0
Yes	Refuge 1 Slope (%)	0.2	Yes	Gutter 1 Slope (%)	2.1
Yes	Refuge 1 X Slope (%)	0.2	Yes	Gutter 1 X Slope (%)	0.0
N/A	Painted X Walk1?	Yes	Yes	DWS 1 Provided?	Yes
N/A	X Walk 1 Direction	To NE	Yes	DWS 1 Contrast?	Yes
N/A	X Walk 1 Width (In)	99.0	No	DWS 1 Length (In)	23.5
N/A	Road 1 Slope (%)	0.3	Yes	DWS 1 Full Width?	Yes
N/A	Road 1 X Slope (%)	2.5	Yes	DWS 1 Offset (In)	1.0
Yes	Refuge 2 Length (In)	48.0	Yes	Gutter 2 Ponding?	No
Yes	Refuge 2 Width (In)	120.0	Yes	Gutter 2 Lip Ht (In)	0.0
Yes	Refuge 2 Slope (%)	0.9	Yes	Gutter 2 Slope (%)	1.3
Yes	Refuge 2 X Slope (%)	0.6	Yes	Gutter 2 X Slope (%)	0.6
N/A	Painted X Walk2?	No	Yes	DWS 2 Provided?	Yes
N/A	X Walk 2 Direction	To S	Yes	DWS 2 Contrast?	Yes
N/A	X Walk 2 Width (In)	N/A	No	DWS 2 Length (In)	23.5

N/A	Road 2 Slope (%)	1.1	Yes	DWS 2 Full Width?	Yes
N/A	Road 2 X Slope (%)	2.4	Yes	DWS 2 Offset (In)	1.0
N/A	Refuge 3 Length (in)	N/A	N/A	Gutter 3 Ponding?	N/A
N/A	Refuge 3 Width (in)	N/A	N/A	Gutter 3 Lip Ht (in)	N/A
N/A	Refuge 3 Slope (%)	N/A	N/A	Gutter 3 Slope (%)	N/A
N/A	Refuge 3 XSlope (%)	N/A	N/A	Gutter 3 XSlope (%)	N/A
N/A	Painted X Walk3?	N/A	N/A	DWS 3 Provided?	N/A
N/A	X Walk 3 Direction	N/A	N/A	DWS 3 Contrast?	N/A
N/A	X Walk 3 Width (in)	N/A	N/A	DWS 3 Length (in)	N/A
N/A	Road 3 Slope (%)	N/A	N/A	DWS 3 Full Width?	N/A
N/A	Road 3 XSlope (%)	N/A	N/A	DWS 3 Offset (in)	N/A
Yes	Any Obstructions?	No	N/A	Storm Grate/Utility Hazard?	No
N/A	Obstruction Type		N/A	Storm Grate/Utility Type	
		N/A			N/A
N/A	Surface Condition	Good

Possible Solutions:

**Remove & Replace Detectable Warning System.**

Total Cost: \$ 1600.00
