# Access Compliance Report

## Public Rights-of-Way

### (Island Curb Cuts)

Intersection ID: 20485	Main Street: FAIRVIEW_RD	Cross Street: ASHLEY_PARK_LN	Location: SW
ADA ID: 5CB4E60871CF	Curb Cut Type: MedianRefuge2	Initial Pass/Fail: Pass	Overall Compliance: No
Severity Score: 15.25			
Codes/Mitigation Info/Possible Solution		Field Measurements/Component Compliance

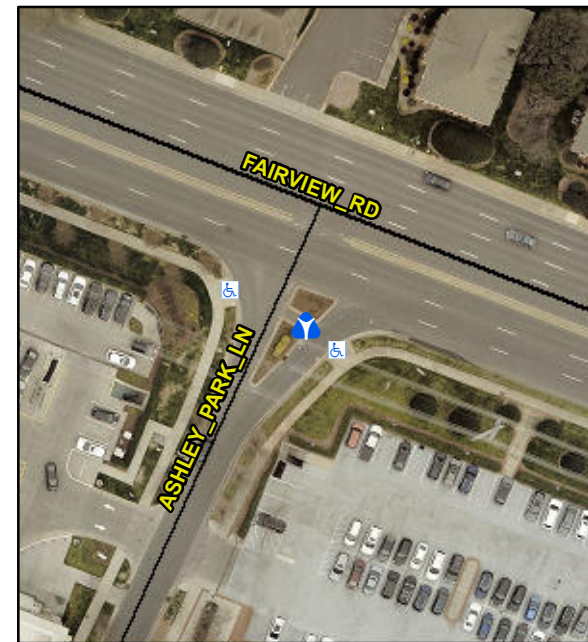
Compliance	Description	Data	Compliance	Description	Data
Yes	Refuge 1 Length (In)	100.0	Yes	Gutter 1 Ponding?	No
Yes	Refuge 1 Width (In)	85.0	Yes	Gutter 1 Lip Ht (In)	0.0
Yes	Refuge 1 Slope (%)	2.5	Yes	Gutter 1 Slope (%)	1.3
Yes	Refuge 1 X Slope (%)	0.6	Yes	Gutter 1 X Slope (%)	0.7
N/A	Painted X Walk1?	No	No	DWS 1 Provided?	No
N/A	X Walk 1 Direction	To SE	N/A	DWS 1 Contrast?	No
N/A	X Walk 1 Width (In)	N/A	N/A	DWS 1 Length (In)	N/A
N/A	Road 1 Slope (%)	0.7	N/A	DWS 1 Full Width?	No
N/A	Road 1 X Slope (%)	2.3	N/A	DWS 1 Offset (In)	N/A
Yes	Refuge 2 Length (In)	100.0	Yes	Gutter 2 Ponding?	No
Yes	Refuge 2 Width (In)	85.0	Yes	Gutter 2 Lip Ht (In)	0.0
Yes	Refuge 2 Slope (%)	1.4	Yes	Gutter 2 Slope (%)	4.3
Yes	Refuge 2 X Slope (%)	0.5	Yes	Gutter 2 X Slope (%)	1.1
N/A	Painted X Walk2?	No	No	DWS 2 Provided?	No
N/A	X Walk 2 Direction	To NW	N/A	DWS 2 Contrast?	No
N/A	X Walk 2 Width (In)	N/A	N/A	DWS 2 Length (In)	N/A
N/A	Road 2 Slope (%)	1.8	N/A	DWS 2 Full Width?	No

**Install Detectable Warning System.**
