# Access Compliance Report

## Public Rights-of-Way

### (Island Curb Cuts)

Intersection ID: 43075	Main Street: SCOTT_AV	Cross Street: ROMANY_RD	Location:	N
ADA ID: 5CF62F3C2CD9	Curb Cut Type: MedianRefuge2	Initial Pass/Fail: Fail	Overall Compliance: No	Severity Score: 1.25
Codes/Mitigation Info/Possible Solution		Field Measurements/Component Compliance

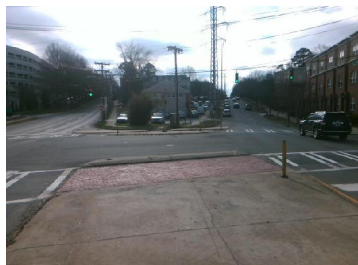
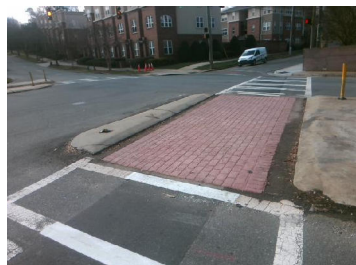
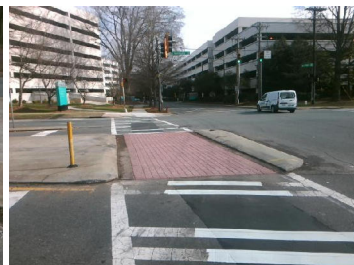
Compliance	Description	Data	Compliance	Description	Data
Yes	Refuge 1 Length (In)	122.0	N/A	Gutter 1 Ponding?	N/A
Yes	Refuge 1 Width (In)	121.0	N/A	Gutter 1 Lip Ht (In)	N/A
Yes	Refuge 1 Slope (%)	2.3	N/A	Gutter 1 Slope (%)	N/A
Yes	Refuge 1 X Slope (%)	3.2	N/A	Gutter 1 X Slope (%)	N/A
N/A	Painted X Walk1?	Yes	N/A	DWS 1 Provided?	N/A
N/A	X Walk 1 Direction	To E	N/A	DWS 1 Contrast?	N/A
N/A	X Walk 1 Width (In)	116.0	N/A	DWS 1 Length (In)	N/A
N/A	Road 1 Slope (%)	0.1	N/A	DWS 1 Full Width?	N/A
N/A	Road 1 X Slope (%)	1.6	N/A	DWS 1 Offset (In)	N/A
Yes	Refuge 2 Length (In)	122.0	N/A	Gutter 2 Ponding?	N/A
Yes	Refuge 2 Width (In)	121.0	N/A	Gutter 2 Lip Ht (In)	N/A
Yes	Refuge 2 Slope (%)	0.4	N/A	Gutter 2 Slope (%)	N/A
Yes	Refuge 2 X Slope (%)	2.7	N/A	Gutter 2 X Slope (%)	N/A
N/A	Painted X Walk2?	Yes	N/A	DWS 2 Provided?	N/A
N/A	X Walk 2 Direction	To W	N/A	DWS 2 Contrast?	N/A
N/A	X Walk 2 Width (In)	118.0	N/A	DWS 2 Length (In)	N/A

N/A	Road 2 Slope (%)	1.1	N/A	DWS 2 Full Width?	N/A
N/A	Road 2 X Slope (%)	1.9	N/A	DWS 2 Offset (In)	N/A
N/A	Refuge 3 Length (in)	N/A	N/A	Gutter 3 Ponding?	N/A
N/A	Refuge 3 Width (in)	N/A	N/A	Gutter 3 Lip Ht (in)	N/A
N/A	Refuge 3 Slope (%)	N/A	N/A	Gutter 3 Slope (%)	N/A
N/A	Refuge 3 XSlope (%)	N/A	N/A	Gutter 3 XSlope (%)	N/A
N/A	Painted X Walk3?	N/A	N/A	DWS 3 Provided?	N/A
N/A	X Walk 3 Direction	N/A	N/A	DWS 3 Contrast?	N/A
N/A	X Walk 3 Width (in)	N/A	N/A	DWS 3 Length (in)	N/A
N/A	Road 3 Slope (%)	N/A	N/A	DWS 3 Full Width?	N/A
N/A	Road 3 XSlope (%)	N/A	N/A	DWS 3 Offset (in)	N/A
Yes	Any Obstructions?	N/A	N/A	Storm Grate/Utility Hazard?	N/A
N/A	Obstruction Type		N/A	Storm Grate/Utility Type	
		N/A			N/A
N/A	Surface Condition	Good

**Remove & Replace Entire Refuge.**

Total Cost: \$ 3000.00
