Access Compliance Report

Public Rights-of-Way

(Island Curb Cuts)

Intersection ID: 43922	Main Street: NORTH_COMMUNITY_HOUSE_RD	Cross Street: JOHNSTON_RD	Location: NE
ADA ID: 5E1BEB51527A	Curb Cut Type: MedianRefuge2	Initial Pass/Fail: Fail	Overall Compliance: No
Codes/Mitigation Info/Possible Solution		Field Measurements/Component Compliance	
Severity Score: 1.25

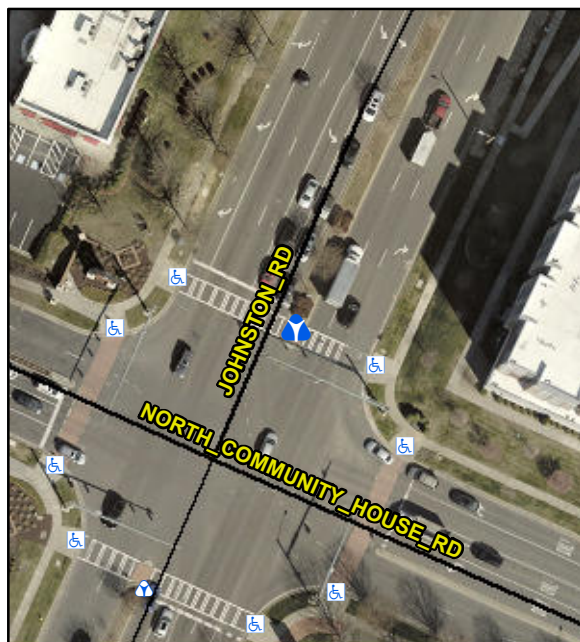
Compliance	Description	Data	Compliance	Description	Data
Yes	Refuge 1 Length (In)	52.5	N/A	Gutter 1 Ponding?	N/A
Yes	Refuge 1 Width (In)	117.0	N/A	Gutter 1 Lip Ht (In)	N/A
Yes	Refuge 1 Slope (%)	3.1	N/A	Gutter 1 Slope (%)	N/A
Yes	Refuge 1 X Slope (%)	2.9	N/A	Gutter 1 X Slope (%)	N/A
N/A	Painted X Walk1?	Yes	N/A	DWS 1 Provided?	N/A
N/A	X Walk 1 Direction	To SE	N/A	DWS 1 Contrast?	N/A
N/A	X Walk 1 Width (In)	118.0	N/A	DWS 1 Length (In)	N/A
N/A	Road 1 Slope (%)	1.5	N/A	DWS 1 Full Width?	N/A
N/A	Road 1 X Slope (%)	1.4	N/A	DWS 1 Offset (In)	N/A
Yes	Refuge 2 Length (In)	52.5	N/A	Gutter 2 Ponding?	N/A
Yes	Refuge 2 Width (In)	117.0	N/A	Gutter 2 Lip Ht (In)	N/A
Yes	Refuge 2 Slope (%)	3.5	N/A	Gutter 2 Slope (%)	N/A
Yes	Refuge 2 X Slope (%)	1.2	N/A	Gutter 2 X Slope (%)	N/A
N/A	Painted X Walk2?	Yes	N/A	DWS 2 Provided?	N/A
N/A	X Walk 2 Direction	To NW	N/A	DWS 2 Contrast?	N/A
N/A	X Walk 2 Width (In)	118.0	N/A	DWS 2 Length (In)	N/A

N/A	Road 2 Slope (%)	1.9	N/A	DWS 2 Full Width?	N/A
N/A	Road 2 X Slope (%)	1.6	N/A	DWS 2 Offset (In)	N/A
N/A	Refuge 3 Length (in)	N/A	N/A	Gutter 3 Ponding?	N/A
N/A	Refuge 3 Width (in)	N/A	N/A	Gutter 3 Lip Ht (in)	N/A
N/A	Refuge 3 Slope (%)	N/A	N/A	Gutter 3 Slope (%)	N/A
N/A	Refuge 3 XSlope (%)	N/A	N/A	Gutter 3 XSlope (%)	N/A
N/A	Painted X Walk3?	N/A	N/A	DWS 3 Provided?	N/A
N/A	X Walk 3 Direction	N/A	N/A	DWS 3 Contrast?	N/A
N/A	X Walk 3 Width (in)	N/A	N/A	DWS 3 Length (in)	N/A
N/A	Road 3 Slope (%)	N/A	N/A	DWS 3 Full Width?	N/A
N/A	Road 3 XSlope (%)	N/A	N/A	DWS 3 Offset (in)	N/A
Yes	Any Obstructions?	N/A	N/A	Storm Grate/Utility Hazard?	N/A
N/A	Obstruction Type		N/A	Storm Grate/Utility Type	
		N/A			N/A
N/A	Surface Condition	Good

Remove & Replace Entire Refuge.
