Access Compliance Report Public Rights-of-Way (Island Curb Cuts)

Intersection ID: 28304 Main Street: LANCASTER_HY Cross Street: JOHNSTON_RD Location: N

ADA ID: 5E77D995BF1F Curb Cut Type: MedianRefuge2 Initial Pass/Fail: Fail Overall Compliance: No Severity Score: 13.75

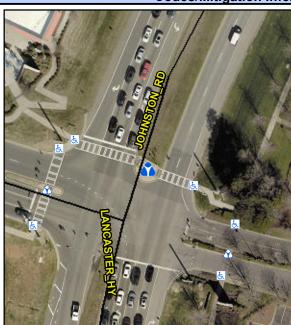
Yes	Refuge 1 Slope (%)	3.4 N	/A	Gutter 1 Slope (%)	N/A
No	Refuge 1 X Slope (%)	5.4 N	/ A	Gutter 1 X Slope (%)	N/A
N/A	Painted X Walk1?	Yes N	/ A	DWS 1 Provided?	N/A
N/A	X Walk 1 Direction	To E N	/ A	DWS 1 Contrast?	N/A
N/A	X Walk 1 Width (In)	104.0 N	/ A	DWS 1 Length (In)	N/A
N/A	Road 1 Slope (%)	4.8 N	/ A	DWS 1 Full Width?	N/A
N/A	Road 1 X Slope (%)	4.4 N	/ A	DWS 1 Offset (In)	N/A
Yes	Refuge 2 Length (In)	15.5 N	/ A	Gutter 2 Ponding?	N/A
Yes	Refuge 2 Width (In)	119.0 N	/ A	Gutter 2 Lip Ht (In)	N/A
Yes	Refuge 2 Slope (%)	2.6 N	/ A	Gutter 2 Slope (%)	N/A
Yes	Refuge 2 X Slope (%)	3.0 N	/ A	Gutter 2 X Slope (%)	N/A
N/A	Painted X Walk2?	Yes N	/ A	DWS 2 Provided?	N/A
N/A	X Walk 2 Direction	To W N	/ A	DWS 2 Contrast?	N/A
N/A	X Walk 2 Width (In)	104.0 N	/ A	DWS 2 Length (In)	N/A
N/A	Road 2 Slope (%)	4.4 N	/ A	DWS 2 Full Width?	N/A
N/A	Road 2 X Slope (%)	2.5 N	/ A	DWS 2 Offset (In)	N/A
N/A	Refuge 3 Length (in)	N/A N	/ A	Gutter 3 Ponding?	N/A

Remove & Replace Entire Refuge.
