Access Compliance Report

Public Rights-of-Way

(Island Curb Cuts)

Intersection ID: 53421	Main Street: ARDREY_KELL_RD	Cross Street: N/A	Location: N
ADA ID: 5EB0970A20BE	Curb Cut Type: MedianRefuge2	Initial Pass/Fail: Fail	Overall Compliance: No
Severity Score: 1.25			
Codes/Mitigation Info/Possible Solution		Field Measurements/Component Compliance

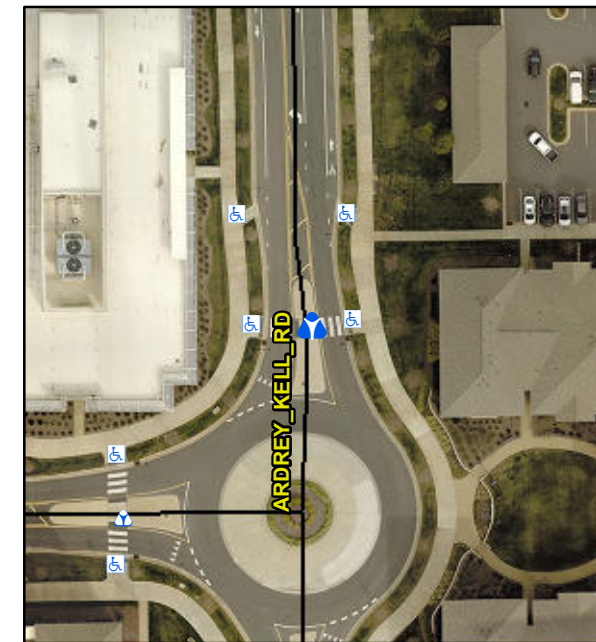
Compliance	Description	Data	Compliance	Description	Data
Yes	Refuge 1 Length (In)	66.5	N/A	Gutter 1 Ponding?	N/A
Yes	Refuge 1 Width (In)	120.0	N/A	Gutter 1 Lip Ht (In)	N/A
Yes	Refuge 1 Slope (%)	2.7	N/A	Gutter 1 Slope (%)	N/A
Yes	Refuge 1 X Slope (%)	1.0	N/A	Gutter 1 X Slope (%)	N/A
N/A	Painted X Walk1?	Yes	N/A	DWS 1 Provided?	N/A
N/A	X Walk 1 Direction	To W	N/A	DWS 1 Contrast?	N/A
N/A	X Walk 1 Width (In)	120.0	N/A	DWS 1 Length (In)	N/A
N/A	Road 1 Slope (%)	0.1	N/A	DWS 1 Full Width?	N/A
N/A	Road 1 X Slope (%)	1.4	N/A	DWS 1 Offset (In)	N/A
Yes	Refuge 2 Length (In)	66.5	N/A	Gutter 2 Ponding?	N/A
Yes	Refuge 2 Width (In)	120.0	N/A	Gutter 2 Lip Ht (In)	N/A
Yes	Refuge 2 Slope (%)	1.7	N/A	Gutter 2 Slope (%)	N/A
Yes	Refuge 2 X Slope (%)	2.1	N/A	Gutter 2 X Slope (%)	N/A
N/A	Painted X Walk2?	Yes	N/A	DWS 2 Provided?	N/A
N/A	X Walk 2 Direction	To E	N/A	DWS 2 Contrast?	N/A
N/A	X Walk 2 Width (In)	120.0	N/A	DWS 2 Length (In)	N/A

N/A	Road 2 Slope (%)	0.7	N/A	DWS 2 Full Width?	N/A
N/A	Road 2 X Slope (%)	2.8	N/A	DWS 2 Offset (In)	N/A
N/A	Refuge 3 Length (in)	N/A	N/A	Gutter 3 Ponding?	N/A
N/A	Refuge 3 Width (in)	N/A	N/A	Gutter 3 Lip Ht (in)	N/A
N/A	Refuge 3 Slope (%)	N/A	N/A	Gutter 3 Slope (%)	N/A
N/A	Refuge 3 XSlope (%)	N/A	N/A	Gutter 3 XSlope (%)	N/A
N/A	Painted X Walk3?	N/A	N/A	DWS 3 Provided?	N/A
N/A	X Walk 3 Direction	N/A	N/A	DWS 3 Contrast?	N/A
N/A	X Walk 3 Width (in)	N/A	N/A	DWS 3 Length (in)	N/A
N/A	Road 3 Slope (%)	N/A	N/A	DWS 3 Full Width?	N/A
N/A	Road 3 XSlope (%)	N/A	N/A	DWS 3 Offset (in)	N/A
Yes	Any Obstructions?	N/A	N/A	Storm Grate/Utility Hazard?	N/A
N/A	Obstruction Type		N/A	Storm Grate/Utility Type	
		N/A			N/A
N/A	Surface Condition	Good

Possible Solutions:

Remove & Replace Entire Refuge.
