# Access Compliance Report

## Public Rights-of-Way

### (Island Curb Cuts)

Intersection ID: 5714	Main Street: JOHN_KIRK_DR	Cross Street: UNIVERSITY_CITY_BV	Location: S
ADA ID: 5F4CFC30A64A	Curb Cut Type: MedianRefuge2	Initial Pass/Fail: Fail	Overall Compliance: No
Severity Score: 25			
Codes/Mitigation Info/Possible Solution		Field Measurements/Component Compliance

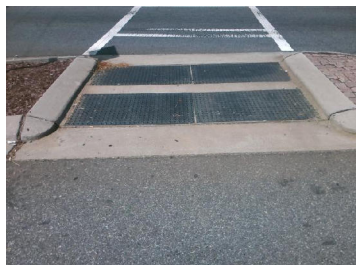
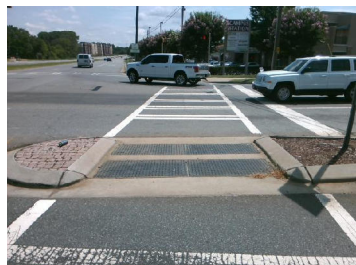
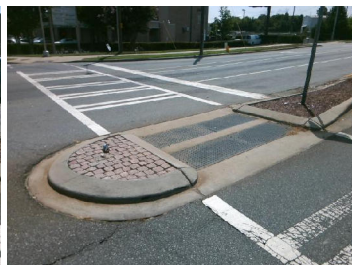
Compliance	Description	Data	Compliance	Description	Data
Yes	Refuge 1 Length (In)	37.5	N/A	Gutter 1 Ponding?	N/A
Yes	Refuge 1 Width (In)	90.0	N/A	Gutter 1 Lip Ht (In)	N/A
No	Refuge 1 Slope (%)	7.0	N/A	Gutter 1 Slope (%)	N/A
Yes	Refuge 1 X Slope (%)	0.6	N/A	Gutter 1 X Slope (%)	N/A
N/A	Painted X Walk1?	Yes	N/A	DWS 1 Provided?	N/A
N/A	X Walk 1 Direction	To NE	N/A	DWS 1 Contrast?	N/A
N/A	X Walk 1 Width (In)	110.0	N/A	DWS 1 Length (In)	N/A
N/A	Road 1 Slope (%)	0.4	N/A	DWS 1 Full Width?	N/A
N/A	Road 1 X Slope (%)	2.5	N/A	DWS 1 Offset (In)	N/A
Yes	Refuge 2 Length (In)	37.5	N/A	Gutter 2 Ponding?	N/A
Yes	Refuge 2 Width (In)	90.0	N/A	Gutter 2 Lip Ht (In)	N/A
No	Refuge 2 Slope (%)	5.2	N/A	Gutter 2 Slope (%)	N/A
Yes	Refuge 2 X Slope (%)	0.1	N/A	Gutter 2 X Slope (%)	N/A
N/A	Painted X Walk2?	Yes	N/A	DWS 2 Provided?	N/A
N/A	X Walk 2 Direction	To SW	N/A	DWS 2 Contrast?	N/A
N/A	X Walk 2 Width (In)	111.0	N/A	DWS 2 Length (In)	N/A

**Remove & Replace Entire Refuge.**
