Access Compliance Report

Public Rights-of-Way

(Island Curb Cuts)

Intersection ID: 17190	Main Street: MURRAYHILL_RD	Cross Street: SCALEYBARK_RD	Location: NW
ADA ID: 629DC4E2CD52	Curb Cut Type: MedianRefuge2	Initial Pass/Fail: Pass	Overall Compliance: No
Severity Score: 7.75			
Codes/Mitigation Info/Possible Solution		Field Measurements/Component Compliance

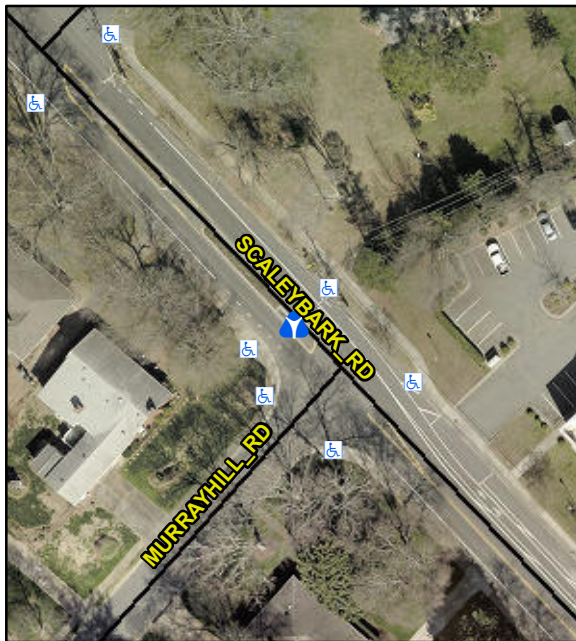
Compliance	Description	Data	Compliance	Description	Data
No	Refuge 1 Length (In)	35.5	Yes	Gutter 1 Ponding?	No
Yes	Refuge 1 Width (In)	87.0	No	Gutter 1 Lip Ht (In)	0.5
Yes	Refuge 1 Slope (%)	1.8	Yes	Gutter 1 Slope (%)	3.8
Yes	Refuge 1 X Slope (%)	0.6	No	Gutter 1 X Slope (%)	2.2
N/A	Painted X Walk1?	No	No	DWS 1 Provided?	Yes
N/A	X Walk 1 Direction	To NE	N/A	DWS 1 Contrast?	Yes
N/A	X Walk 1 Width (In)	N/A	N/A	DWS 1 Length (In)	24.0
N/A	Road 1 Slope (%)	0.1	N/A	DWS 1 Full Width?	Yes
N/A	Road 1 X Slope (%)	2.1	N/A	DWS 1 Offset (In)	1.0
No	Refuge 2 Length (In)	35.5	Yes	Gutter 2 Ponding?	No
Yes	Refuge 2 Width (In)	87.0	No	Gutter 2 Lip Ht (In)	0.5
Yes	Refuge 2 Slope (%)	2.7	Yes	Gutter 2 Slope (%)	1.2
Yes	Refuge 2 X Slope (%)	0.0	Yes	Gutter 2 X Slope (%)	0.2
N/A	Painted X Walk2?	No	N/A	DWS 2 Provided?	N/A
N/A	X Walk 2 Direction	To SW	N/A	DWS 2 Contrast?	N/A
N/A	X Walk 2 Width (In)	N/A	N/A	DWS 2 Length (In)	24.0
N/A	Road 2 Slope (%)	0.0	N/A	DWS 2 Full Width?	Yes

N/A	Road 2 X Slope (%)	2.4	N/A	DWS 2 Offset (In)	1.0
N/A	Refuge 3 Length (in)	N/A	N/A	Gutter 3 Ponding?	N/A
N/A	Refuge 3 Width (in)	N/A	N/A	Gutter 3 Lip Ht (in)	N/A
N/A	Refuge 3 Slope (%)	N/A	N/A	Gutter 3 Slope (%)	N/A
N/A	Refuge 3 XSlope (%)	N/A	N/A	Gutter 3 XSlope (%)	N/A
N/A	Painted X Walk3?	N/A	N/A	DWS 3 Provided?	N/A
N/A	X Walk 3 Direction	N/A	N/A	DWS 3 Contrast?	N/A
N/A	X Walk 3 Width (in)	N/A	N/A	DWS 3 Length (in)	N/A
N/A	Road 3 Slope (%)	N/A	N/A	DWS 3 Full Width?	N/A
N/A	Road 3 XSlope (%)	N/A	N/A	DWS 3 Offset (in)	N/A
Yes	Any Obstructions?	N/A	N/A	Storm Grate/Utility Hazard?	No
N/A	Obstruction Type		N/A	Storm Grate/Utility Type	
		N/A			N/A
N/A	Surface Condition	Good

Possible Solutions:

**Remove & Replace Entire Refuge.
Grind Gutter Lip. Remove & Replace
Gutter.**
