Access Compliance Report

Public Rights-of-Way

(Island Curb Cuts)

Intersection ID: 54265	Main Street: JOHNSTON_OEHLE_R_D	Cross Street: N/A	Location: E
ADA ID: 62ABDBB5DC57	Curb Cut Type: MedianRefuge2	Initial Pass/Fail: Fail	Overall Compliance: No
Codes/Mitigation Info/Possible Solution		Field Measurements/Component Compliance	
		Severity Score: 0

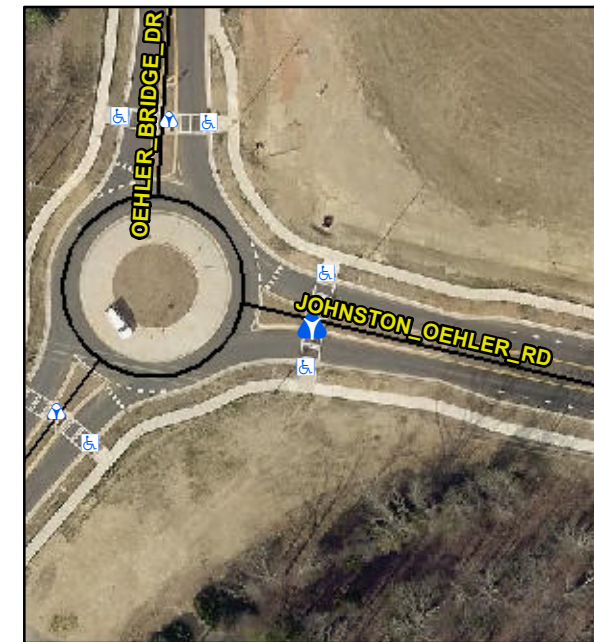
Compliance	Description	Data	Compliance	Description	Data
Yes	Refuge 1 Length (In)	48.0	N/A	Gutter 1 Ponding?	N/A
Yes	Refuge 1 Width (In)	117.0	N/A	Gutter 1 Lip Ht (In)	N/A
Yes	Refuge 1 Slope (%)	0.8	N/A	Gutter 1 Slope (%)	N/A
Yes	Refuge 1 X Slope (%)	1.6	N/A	Gutter 1 X Slope (%)	N/A
N/A	Painted X Walk1?	Yes	N/A	DWS 1 Provided?	N/A
N/A	X Walk 1 Direction	To S	N/A	DWS 1 Contrast?	N/A
N/A	X Walk 1 Width (In)	104.0	N/A	DWS 1 Length (In)	N/A
N/A	Road 1 Slope (%)	0.5	N/A	DWS 1 Full Width?	N/A
N/A	Road 1 X Slope (%)	1.8	N/A	DWS 1 Offset (In)	N/A
Yes	Refuge 2 Length (In)	48.0	N/A	Gutter 2 Ponding?	N/A
Yes	Refuge 2 Width (In)	117.0	N/A	Gutter 2 Lip Ht (In)	N/A
Yes	Refuge 2 Slope (%)	1.3	N/A	Gutter 2 Slope (%)	N/A
Yes	Refuge 2 X Slope (%)	2.5	N/A	Gutter 2 X Slope (%)	N/A
N/A	Painted X Walk2?	Yes	N/A	DWS 2 Provided?	N/A
N/A	X Walk 2 Direction	To N	N/A	DWS 2 Contrast?	N/A
N/A	X Walk 2 Width (In)	104.0	N/A	DWS 2 Length (In)	N/A

N/A	Road 2 Slope (%)	1.5	N/A	DWS 2 Full Width?	N/A
N/A	Road 2 X Slope (%)	1.2	N/A	DWS 2 Offset (In)	N/A
N/A	Refuge 3 Length (in)	N/A	N/A	Gutter 3 Ponding?	N/A
N/A	Refuge 3 Width (in)	N/A	N/A	Gutter 3 Lip Ht (in)	N/A
N/A	Refuge 3 Slope (%)	N/A	N/A	Gutter 3 Slope (%)	N/A
N/A	Refuge 3 XSlope (%)	N/A	N/A	Gutter 3 XSlope (%)	N/A
N/A	Painted X Walk3?	No	N/A	DWS 3 Provided?	N/A
N/A	X Walk 3 Direction	N/A	N/A	DWS 3 Contrast?	N/A
N/A	X Walk 3 Width (in)	N/A	N/A	DWS 3 Length (in)	N/A
N/A	Road 3 Slope (%)	N/A	N/A	DWS 3 Full Width?	N/A
N/A	Road 3 XSlope (%)	N/A	N/A	DWS 3 Offset (in)	N/A
Yes	Any Obstructions?	N/A	N/A	Storm Grate/Utility Hazard?	N/A
N/A	Obstruction Type		N/A	Storm Grate/Utility Type	
		N/A			N/A
N/A	Surface Condition	Good

Remove & Replace Entire Refuge.
