Access Compliance Report

Public Rights-of-Way

(Island Curb Cuts)

Intersection ID: 27325	Main Street: TILLEY_MORRIS_RD	Cross Street: N/A	Location: E
ADA ID: 63D117B06C45	Curb Cut Type: IslandRefuge2	Initial Pass/Fail: Fail	Overall Compliance: No
Codes/Mitigation Info/Possible Solution		Field Measurements/Component Compliance

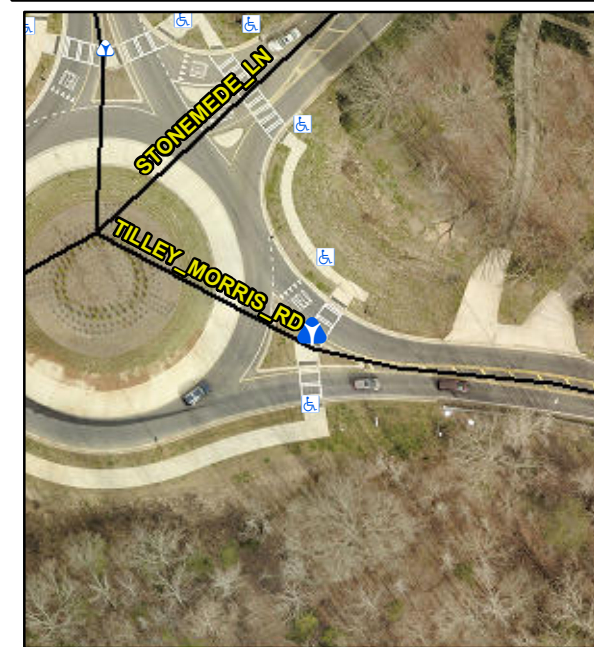
Compliance	Description	Data	Compliance	Description	Data
Yes	Refuge 1 Length (In)	56.0	N/A	Gutter 1 Ponding?	N/A
Yes	Refuge 1 Width (In)	119.0	N/A	Gutter 1 Lip Ht (In)	N/A
Yes	Refuge 1 Slope (%)	1.8	N/A	Gutter 1 Slope (%)	N/A
Yes	Refuge 1 X Slope (%)	2.8	N/A	Gutter 1 X Slope (%)	N/A
N/A	Painted X Walk1?	Yes	N/A	DWS 1 Provided?	N/A
N/A	X Walk 1 Direction	To N	N/A	DWS 1 Contrast?	N/A
N/A	X Walk 1 Width (In)	112.0	N/A	DWS 1 Length (In)	N/A
N/A	Road 1 Slope (%)	3.8	N/A	DWS 1 Full Width?	N/A
N/A	Road 1 X Slope (%)	3.7	N/A	DWS 1 Offset (In)	N/A
Yes	Refuge 2 Length (In)	75.0	N/A	Gutter 2 Ponding?	N/A
Yes	Refuge 2 Width (In)	119.0	N/A	Gutter 2 Lip Ht (In)	N/A
Yes	Refuge 2 Slope (%)	2.9	N/A	Gutter 2 Slope (%)	N/A
Yes	Refuge 2 X Slope (%)	1.8	N/A	Gutter 2 X Slope (%)	N/A
N/A	Painted X Walk2?	Yes	N/A	DWS 2 Provided?	N/A
N/A	X Walk 2 Direction	To S	N/A	DWS 2 Contrast?	N/A
N/A	X Walk 2 Width (In)	112.0	N/A	DWS 2 Length (In)	N/A

N/A	Road 2 Slope (%)	2.1	N/A	DWS 2 Full Width?	N/A
N/A	Road 2 X Slope (%)	4.9	N/A	DWS 2 Offset (In)	N/A
N/A	Refuge 3 Length (in)	N/A	N/A	Gutter 3 Ponding?	N/A
N/A	Refuge 3 Width (in)	N/A	N/A	Gutter 3 Lip Ht (in)	N/A
N/A	Refuge 3 Slope (%)	N/A	N/A	Gutter 3 Slope (%)	N/A
N/A	Refuge 3 XSlope (%)	N/A	N/A	Gutter 3 XSlope (%)	N/A
N/A	Painted X Walk3?	N/A	N/A	DWS 3 Provided?	N/A
N/A	X Walk 3 Direction	N/A	N/A	DWS 3 Contrast?	N/A
N/A	X Walk 3 Width (in)	N/A	N/A	DWS 3 Length (in)	N/A
N/A	Road 3 Slope (%)	N/A	N/A	DWS 3 Full Width?	N/A
N/A	Road 3 XSlope (%)	N/A	N/A	DWS 3 Offset (in)	N/A
Yes	Any Obstructions?	N/A	N/A	Storm Grate/Utility Hazard?	N/A
N/A	Obstruction Type		N/A	Storm Grate/Utility Type	
		N/A			N/A
N/A	Surface Condition	Good

Possible Solutions:

Remove & Replace Entire Refuge.
