Access Compliance Report

Public Rights-of-Way

(Island Curb Cuts)

Intersection ID: 19817	Main Street: MONROE_RD	Cross Street: TIMBER_SPRINGS_DR	Location: NE
ADA ID: 64DD3FA47134	Curb Cut Type: MedianRefuge2	Initial Pass/Fail: Fail	Overall Compliance: No
Codes/Mitigation Info/Possible Solution		Field Measurements/Component Compliance

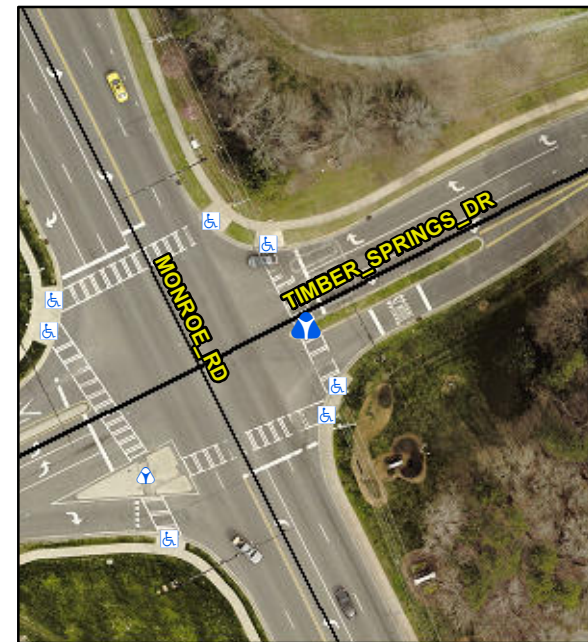
Compliance	Description	Data	Compliance	Description	Data
No	Refuge 1 Length (In)	27.5	N/A	Gutter 1 Ponding?	N/A
Yes	Refuge 1 Width (In)	84.0	N/A	Gutter 1 Lip Ht (In)	N/A
No	Refuge 1 Slope (%)	6.6	N/A	Gutter 1 Slope (%)	N/A
Yes	Refuge 1 X Slope (%)	2.3	N/A	Gutter 1 X Slope (%)	N/A
N/A	Painted X Walk1?	Yes	N/A	DWS 1 Provided?	N/A
N/A	X Walk 1 Direction	To NW	N/A	DWS 1 Contrast?	N/A
N/A	X Walk 1 Width (In)	112.0	N/A	DWS 1 Length (In)	N/A
N/A	Road 1 Slope (%)	0.2	N/A	DWS 1 Full Width?	N/A
N/A	Road 1 X Slope (%)	1.4	N/A	DWS 1 Offset (In)	N/A
No	Refuge 2 Length (In)	27.5	N/A	Gutter 2 Ponding?	N/A
Yes	Refuge 2 Width (In)	84.0	N/A	Gutter 2 Lip Ht (In)	N/A
Yes	Refuge 2 Slope (%)	4.8	N/A	Gutter 2 Slope (%)	N/A
Yes	Refuge 2 X Slope (%)	3.1	N/A	Gutter 2 X Slope (%)	N/A
N/A	Painted X Walk2?	Yes	N/A	DWS 2 Provided?	N/A
N/A	X Walk 2 Direction	To SE	N/A	DWS 2 Contrast?	N/A
N/A	X Walk 2 Width (In)	114.0	N/A	DWS 2 Length (In)	N/A

N/A	Road 2 Slope (%)	1.1	N/A	DWS 2 Full Width?	N/A
N/A	Road 2 X Slope (%)	3.7	N/A	DWS 2 Offset (In)	N/A
N/A	Refuge 3 Length (in)	N/A	N/A	Gutter 3 Ponding?	N/A
N/A	Refuge 3 Width (in)	N/A	N/A	Gutter 3 Lip Ht (in)	N/A
N/A	Refuge 3 Slope (%)	N/A	N/A	Gutter 3 Slope (%)	N/A
N/A	Refuge 3 XSlope (%)	N/A	N/A	Gutter 3 XSlope (%)	N/A
N/A	Painted X Walk3?	N/A	N/A	DWS 3 Provided?	N/A
N/A	X Walk 3 Direction	N/A	N/A	DWS 3 Contrast?	N/A
N/A	X Walk 3 Width (in)	N/A	N/A	DWS 3 Length (in)	N/A
N/A	Road 3 Slope (%)	N/A	N/A	DWS 3 Full Width?	N/A
N/A	Road 3 XSlope (%)	N/A	N/A	DWS 3 Offset (in)	N/A
Yes	Any Obstructions?	N/A	N/A	Storm Grate/Utility Hazard?	N/A
N/A	Obstruction Type		N/A	Storm Grate/Utility Type	
		N/A			N/A
N/A	Surface Condition	Good

Remove & Replace Entire Refuge.

\$ 3000.00
