Access Compliance Report

Public Rights-of-Way

(Island Curb Cuts)

Intersection ID: 28003	Main Street: COMMUNITY HOUSE RD	Cross Street: WILLOW ROCK DR	Location: S
ADA ID: 6533316816EA	Curb Cut Type: MedianRefuge2	Initial Pass/Fail: Fail	Overall Compliance: No
Codes/Mitigation Info/Possible Solution		Field Measurements/Component Compliance	
Severity Score: 1.25

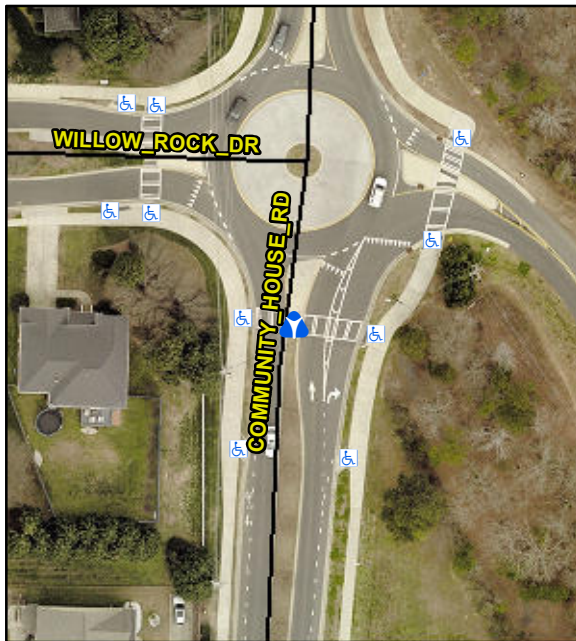
Compliance	Description	Data	Compliance	Description	Data
No	Refuge 1 Length (In)	29.0	N/A	Gutter 1 Ponding?	N/A
Yes	Refuge 1 Width (In)	120.0	N/A	Gutter 1 Lip Ht (In)	N/A
Yes	Refuge 1 Slope (%)	2.7	N/A	Gutter 1 Slope (%)	N/A
Yes	Refuge 1 X Slope (%)	3.1	N/A	Gutter 1 X Slope (%)	N/A
N/A	Painted X Walk1?	Yes	N/A	DWS 1 Provided?	N/A
N/A	X Walk 1 Direction	To W	N/A	DWS 1 Contrast?	N/A
N/A	X Walk 1 Width (In)	129.0	N/A	DWS 1 Length (In)	N/A
N/A	Road 1 Slope (%)	3.4	N/A	DWS 1 Full Width?	N/A
N/A	Road 1 X Slope (%)	6.5	N/A	DWS 1 Offset (In)	N/A
No	Refuge 2 Length (In)	29.0	N/A	Gutter 2 Ponding?	N/A
Yes	Refuge 2 Width (In)	120.0	N/A	Gutter 2 Lip Ht (In)	N/A
Yes	Refuge 2 Slope (%)	0.3	N/A	Gutter 2 Slope (%)	N/A
Yes	Refuge 2 X Slope (%)	2.8	N/A	Gutter 2 X Slope (%)	N/A
N/A	Painted X Walk2?	Yes	N/A	DWS 2 Provided?	N/A
N/A	X Walk 2 Direction	To E	N/A	DWS 2 Contrast?	N/A
N/A	X Walk 2 Width (In)	129.0	N/A	DWS 2 Length (In)	N/A

N/A	Road 2 Slope (%)	0.9	N/A	DWS 2 Full Width?	N/A
N/A	Road 2 X Slope (%)	1.1	N/A	DWS 2 Offset (In)	N/A
N/A	Refuge 3 Length (in)	N/A	N/A	Gutter 3 Ponding?	N/A
N/A	Refuge 3 Width (in)	N/A	N/A	Gutter 3 Lip Ht (in)	N/A
N/A	Refuge 3 Slope (%)	N/A	N/A	Gutter 3 Slope (%)	N/A
N/A	Refuge 3 XSlope (%)	N/A	N/A	Gutter 3 XSlope (%)	N/A
N/A	Painted X Walk3?	N/A	N/A	DWS 3 Provided?	N/A
N/A	X Walk 3 Direction	N/A	N/A	DWS 3 Contrast?	N/A
N/A	X Walk 3 Width (in)	N/A	N/A	DWS 3 Length (in)	N/A
N/A	Road 3 Slope (%)	N/A	N/A	DWS 3 Full Width?	N/A
N/A	Road 3 XSlope (%)	N/A	N/A	DWS 3 Offset (in)	N/A
Yes	Any Obstructions?	N/A	N/A	Storm Grate/Utility Hazard?	N/A
N/A	Obstruction Type		N/A	Storm Grate/Utility Type	
		N/A			N/A
N/A	Surface Condition	Good

Remove & Replace Entire Refuge.
