Access Compliance Report

Public Rights-of-Way

(Island Curb Cuts)

Intersection ID: 10015278	Main Street: OLD_CONCORD_RD	Cross Street: N/A	Location:	W
ADA ID: 6596E96B1813	Curb Cut Type: MedianRefuge2	Initial Pass/Fail: Pass	Overall Compliance: No	Severity Score: 0
Codes/Mitigation Info/Possible Solution		Field Measurements/Component Compliance

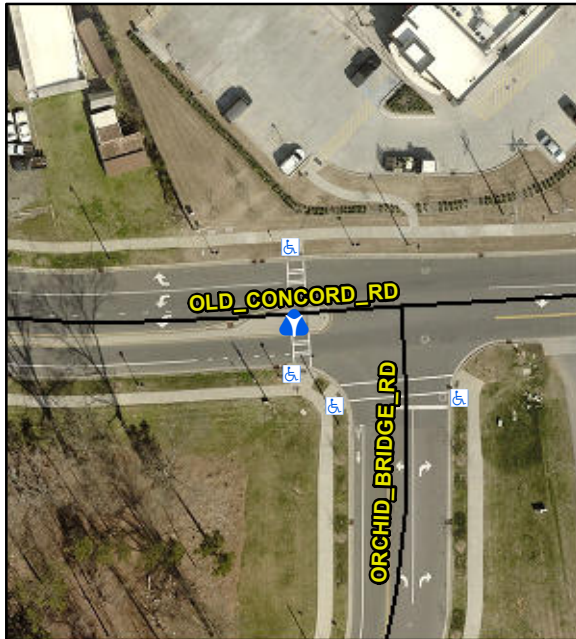
N/A	Road 2 Slope (%)	0.2	Yes	DWS 2 Full Width?	Yes
N/A	Road 2 X Slope (%)	3.0	No	DWS 2 Offset (In)	3.0
N/A	Refuge 3 Length (in)	N/A	N/A	Gutter 3 Ponding?	N/A
N/A	Refuge 3 Width (in)	N/A	N/A	Gutter 3 Lip Ht (in)	N/A
N/A	Refuge 3 Slope (%)	N/A	N/A	Gutter 3 Slope (%)	N/A
N/A	Refuge 3 XSlope (%)	N/A	N/A	Gutter 3 XSlope (%)	N/A
N/A	Painted X Walk3?	N/A	N/A	DWS 3 Provided?	N/A
N/A	X Walk 3 Direction	N/A	N/A	DWS 3 Contrast?	N/A
N/A	X Walk 3 Width (in)	N/A	N/A	DWS 3 Length (in)	N/A
N/A	Road 3 Slope (%)	N/A	N/A	DWS 3 Full Width?	N/A
N/A	Road 3 XSlope (%)	N/A	N/A	DWS 3 Offset (in)	N/A
Yes	Any Obstructions?	N/A	N/A	Storm Grate/Utility Hazard?	No
N/A	Obstruction Type		N/A	Storm Grate/Utility Type	
		N/A			N/A
N/A	Surface Condition	Good

Remove & Replace Detectable Warning System.
