Access Compliance Report

Public Rights-of-Way

(Island Curb Cuts)

Intersection ID: 5704	Main Street: W_W_T_HARRIS_BV	Cross Street: N_TRYON_ST	Location: E
ADA ID: 67CBC6CE26AB	Curb Cut Type: MedianRefuge2	Initial Pass/Fail: Pass	Overall Compliance: No
Severity Score: 0			
Codes/Mitigation Info/Possible Solution		Field Measurements/Component Compliance

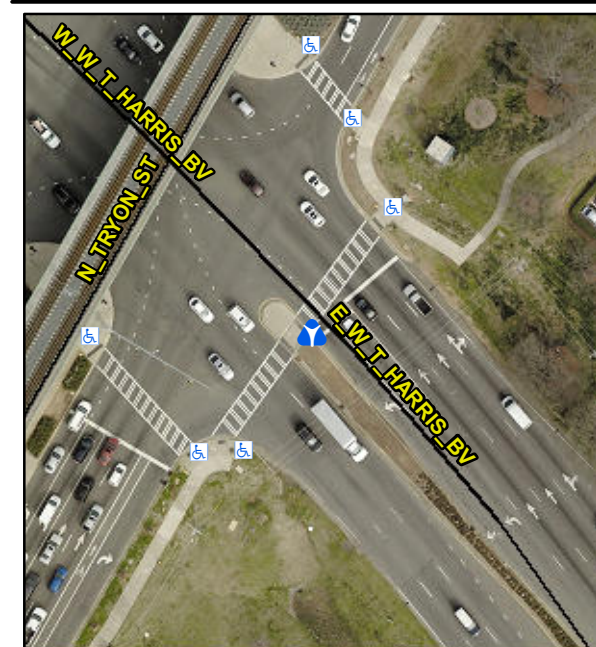
Compliance	Description	Data	Compliance	Description	Data
Yes	Refuge 1 Length (In)	81.0	No	Gutter 1 Ponding?	Yes
Yes	Refuge 1 Width (In)	120.0	Yes	Gutter 1 Lip Ht (In)	0.0
Yes	Refuge 1 Slope (%)	0.2	Yes	Gutter 1 Slope (%)	1.8
Yes	Refuge 1 X Slope (%)	0.3	Yes	Gutter 1 X Slope (%)	1.0
N/A	Painted X Walk1?	Yes	Yes	DWS 1 Provided?	Yes
N/A	X Walk 1 Direction	To NE	Yes	DWS 1 Contrast?	Yes
N/A	X Walk 1 Width (In)	120.0	Yes	DWS 1 Length (In)	24.0
N/A	Road 1 Slope (%)	0.9	Yes	DWS 1 Full Width?	Yes
N/A	Road 1 X Slope (%)	0.4	Yes	DWS 1 Offset (In)	0.0
Yes	Refuge 2 Length (In)	81.0	No	Gutter 2 Ponding?	Yes
Yes	Refuge 2 Width (In)	120.0	Yes	Gutter 2 Lip Ht (In)	0.0
Yes	Refuge 2 Slope (%)	0.7	Yes	Gutter 2 Slope (%)	3.5
Yes	Refuge 2 X Slope (%)	0.2	Yes	Gutter 2 X Slope (%)	0.1
N/A	Painted X Walk2?	Yes	Yes	DWS 2 Provided?	Yes
N/A	X Walk 2 Direction	To SW	Yes	DWS 2 Contrast?	Yes
N/A	X Walk 2 Width (In)	120.0	Yes	DWS 2 Length (In)	24.0

Possible Solutions:

Fix Gutter Ponding.
