# Access Compliance Report

## Public Rights-of-Way

### (Island Curb Cuts)

Intersection ID: 52293	Main Street: N_I-85_SERVICE_RD	Cross Street: N_TRYON_ST	Location: NW
ADA ID: 685F24ACF4DF	Curb Cut Type: MedianRefuge2	Initial Pass/Fail: Pass	Overall Compliance: No
Severity Score: 15.25			
Codes/Mitigation Info/Possible Solution		Field Measurements/Component Compliance

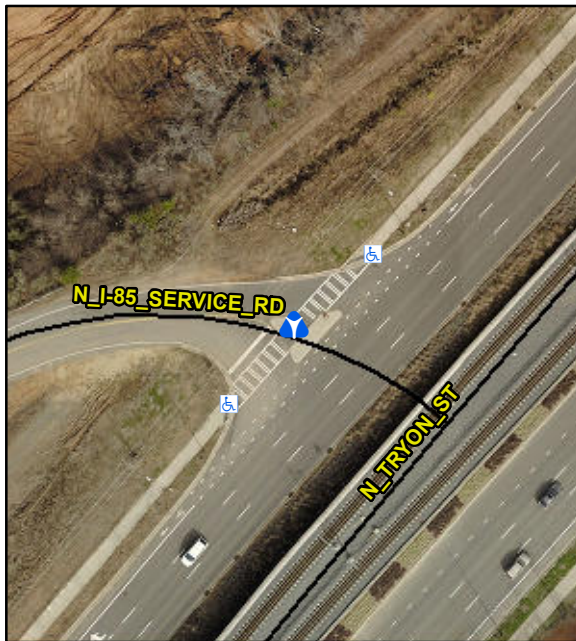
Compliance	Description	Data	Compliance	Description	Data
Yes	Refuge 1 Length (In)	60.0	No	Gutter 1 Ponding?	Yes
Yes	Refuge 1 Width (In)	96.0	Yes	Gutter 1 Lip Ht (In)	0.0
Yes	Refuge 1 Slope (%)	3.3	Yes	Gutter 1 Slope (%)	2.1
Yes	Refuge 1 X Slope (%)	0.1	Yes	Gutter 1 X Slope (%)	0.8
N/A	Painted X Walk1?	Yes	No	DWS 1 Provided?	No
N/A	X Walk 1 Direction	To SW	N/A	DWS 1 Contrast?	No
N/A	X Walk 1 Width (In)	120.0	N/A	DWS 1 Length (In)	N/A
N/A	Road 1 Slope (%)	1.8	N/A	DWS 1 Full Width?	No
N/A	Road 1 X Slope (%)	0.8	N/A	DWS 1 Offset (In)	N/A
Yes	Refuge 2 Length (In)	60.0	No	Gutter 2 Ponding?	Yes
Yes	Refuge 2 Width (In)	96.0	Yes	Gutter 2 Lip Ht (In)	0.0
Yes	Refuge 2 Slope (%)	1.4	Yes	Gutter 2 Slope (%)	2.7
Yes	Refuge 2 X Slope (%)	1.0	Yes	Gutter 2 X Slope (%)	1.8
N/A	Painted X Walk2?	Yes	No	DWS 2 Provided?	No
N/A	X Walk 2 Direction	To NE	N/A	DWS 2 Contrast?	No
N/A	X Walk 2 Width (In)	120.0	N/A	DWS 2 Length (In)	N/A

N/A	Road 2 Slope (%)	1.4	N/A	DWS 2 Full Width?	No
N/A	Road 2 X Slope (%)	1.7	N/A	DWS 2 Offset (In)	N/A
N/A	Refuge 3 Length (in)	N/A	N/A	Gutter 3 Ponding?	No
N/A	Refuge 3 Width (in)	N/A	N/A	Gutter 3 Lip Ht (in)	N/A
N/A	Refuge 3 Slope (%)	N/A	N/A	Gutter 3 Slope (%)	N/A
N/A	Refuge 3 XSlope (%)	N/A	N/A	Gutter 3 XSlope (%)	N/A
N/A	Painted X Walk3?	No	N/A	DWS 3 Provided?	N/A
N/A	X Walk 3 Direction	N/A	N/A	DWS 3 Contrast?	N/A
N/A	X Walk 3 Width (in)	N/A	N/A	DWS 3 Length (in)	N/A
N/A	Road 3 Slope (%)	N/A	N/A	DWS 3 Full Width?	N/A
N/A	Road 3 XSlope (%)	N/A	N/A	DWS 3 Offset (in)	N/A
Yes	Any Obstructions?	No	N/A	Storm Grate/Utility Hazard?	No
N/A	Obstruction Type		N/A	Storm Grate/Utility Type	
		N/A			N/A
N/A	Surface Condition	Good

**Install Detectable Warning System.  
Fix Gutter Ponding.**
