# Access Compliance Report

## Public Rights-of-Way

### (Island Curb Cuts)

Intersection ID: 53488	Main Street: WAVERLY_WALK_AV	Cross Street: MATTHEWS FARM LN	Location: N
ADA ID: 6923F6E82A5C	Curb Cut Type: MedianRefuge2	Initial Pass/Fail: Fail	Overall Compliance: No
Codes/Mitigation Info/Possible Solution		Field Measurements/Component Compliance

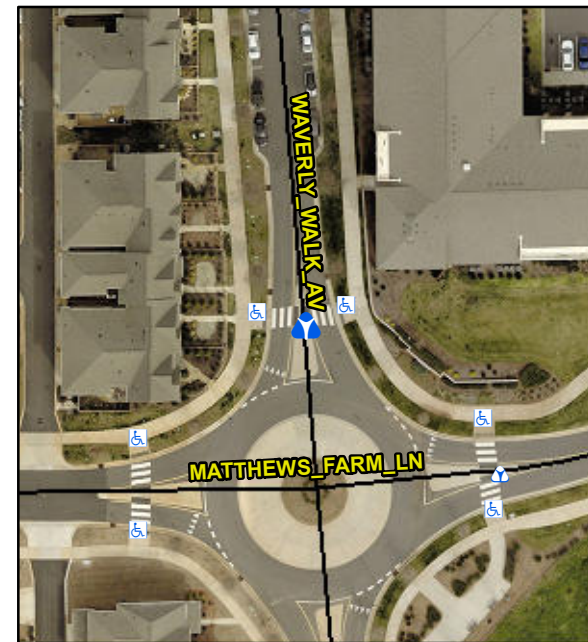
Compliance	Description	Data	Compliance	Description	Data
Yes	Refuge 1 Length (In)	37.0	N/A	Gutter 1 Ponding?	N/A
Yes	Refuge 1 Width (In)	120.0	N/A	Gutter 1 Lip Ht (In)	N/A
Yes	Refuge 1 Slope (%)	0.5	N/A	Gutter 1 Slope (%)	N/A
Yes	Refuge 1 X Slope (%)	3.8	N/A	Gutter 1 X Slope (%)	N/A
N/A	Painted X Walk1?	Yes	N/A	DWS 1 Provided?	N/A
N/A	X Walk 1 Direction	To W	N/A	DWS 1 Contrast?	N/A
N/A	X Walk 1 Width (In)	121.0	N/A	DWS 1 Length (In)	N/A
N/A	Road 1 Slope (%)	2.6	N/A	DWS 1 Full Width?	N/A
N/A	Road 1 X Slope (%)	4.3	N/A	DWS 1 Offset (In)	N/A
Yes	Refuge 2 Length (In)	37.0	N/A	Gutter 2 Ponding?	N/A
Yes	Refuge 2 Width (In)	120.0	N/A	Gutter 2 Lip Ht (In)	N/A
Yes	Refuge 2 Slope (%)	0.4	N/A	Gutter 2 Slope (%)	N/A
Yes	Refuge 2 X Slope (%)	3.4	N/A	Gutter 2 X Slope (%)	N/A
N/A	Painted X Walk2?	Yes	N/A	DWS 2 Provided?	N/A
N/A	X Walk 2 Direction	To E	N/A	DWS 2 Contrast?	N/A
N/A	X Walk 2 Width (In)	122.0	N/A	DWS 2 Length (In)	N/A

N/A	Road 2 Slope (%)	1.9	N/A	DWS 2 Full Width?	N/A
N/A	Road 2 X Slope (%)	3.4	N/A	DWS 2 Offset (In)	N/A
N/A	Refuge 3 Length (in)	N/A	N/A	Gutter 3 Ponding?	N/A
N/A	Refuge 3 Width (in)	N/A	N/A	Gutter 3 Lip Ht (in)	N/A
N/A	Refuge 3 Slope (%)	N/A	N/A	Gutter 3 Slope (%)	N/A
N/A	Refuge 3 XSlope (%)	N/A	N/A	Gutter 3 XSlope (%)	N/A
N/A	Painted X Walk3?	N/A	N/A	DWS 3 Provided?	N/A
N/A	X Walk 3 Direction	N/A	N/A	DWS 3 Contrast?	N/A
N/A	X Walk 3 Width (in)	N/A	N/A	DWS 3 Length (in)	N/A
N/A	Road 3 Slope (%)	N/A	N/A	DWS 3 Full Width?	N/A
N/A	Road 3 XSlope (%)	N/A	N/A	DWS 3 Offset (in)	N/A
Yes	Any Obstructions?	N/A	N/A	Storm Grate/Utility Hazard?	N/A
N/A	Obstruction Type		N/A	Storm Grate/Utility Type	
		N/A			N/A
N/A	Surface Condition	Good

**Remove & Replace Entire Refuge.**

**\$ 3000.00**
