Access Compliance Report

Public Rights-of-Way

(Island Curb Cuts)

Intersection ID: 11318	Main Street: GRANDIN_RD	Cross Street: W_4TH_ST_EXT	Location: NW
ADA ID: 6B361C65FBBF	Curb Cut Type: MedianRefuge2	Initial Pass/Fail: Pass	Overall Compliance: No
Severity Score: 0.25			
Codes/Mitigation Info/Possible Solution		Field Measurements/Component Compliance

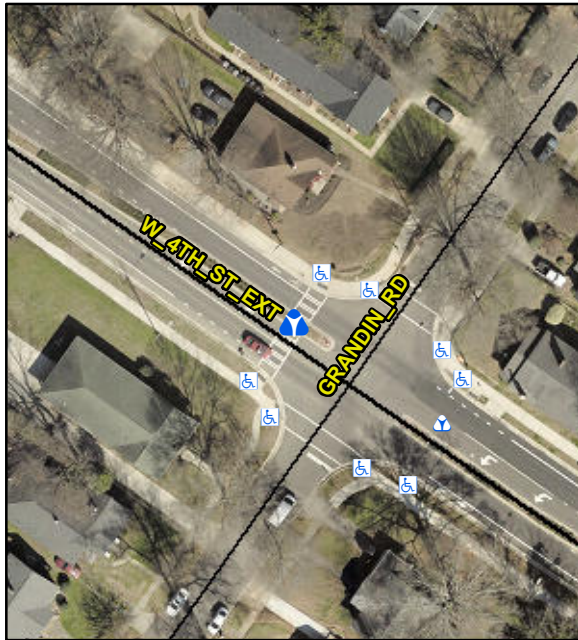
Compliance	Description	Data	Compliance	Description	Data
No	Refuge 1 Length (In)	28.0	Yes	Gutter 1 Ponding?	No
Yes	Refuge 1 Width (In)	100.0	Yes	Gutter 1 Lip Ht (In)	0.0
Yes	Refuge 1 Slope (%)	1.8	Yes	Gutter 1 Slope (%)	3.0
Yes	Refuge 1 X Slope (%)	1.1	Yes	Gutter 1 X Slope (%)	0.2
N/A	Painted X Walk1?	No	No	DWS 1 Provided?	Yes
N/A	X Walk 1 Direction	To NE	N/A	DWS 1 Contrast?	Yes
N/A	X Walk 1 Width (In)	N/A	N/A	DWS 1 Length (In)	24.0
N/A	Road 1 Slope (%)	0.7	N/A	DWS 1 Full Width?	Yes
N/A	Road 1 X Slope (%)	1.8	N/A	DWS 1 Offset (In)	0.0
No	Refuge 2 Length (In)	28.0	Yes	Gutter 2 Ponding?	No
Yes	Refuge 2 Width (In)	100.0	Yes	Gutter 2 Lip Ht (In)	0.0
Yes	Refuge 2 Slope (%)	2.3	Yes	Gutter 2 Slope (%)	2.6
Yes	Refuge 2 X Slope (%)	0.8	No	Gutter 2 X Slope (%)	2.1
N/A	Painted X Walk2?	No	No	DWS 2 Provided?	Yes
N/A	X Walk 2 Direction	To SW	N/A	DWS 2 Contrast?	Yes
N/A	X Walk 2 Width (In)	N/A	N/A	DWS 2 Length (In)	24.0

Remove & Replace Entire Refuge.
Remove & Replace Gutter.
