Access Compliance Report

Public Rights-of-Way

(Island Curb Cuts)

Intersection ID: 48160	Main Street: NORTHLAKE CENTRE PY	Cross Street: N/A	Location: SW
ADA ID: 6B961CE908D7	Curb Cut Type: MedianRefuge2	Initial Pass/Fail: Fail	Overall Compliance: No
Severity Score: 1.25			
Codes/Mitigation Info/Possible Solution		Field Measurements/Component Compliance

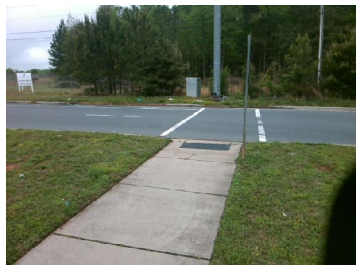
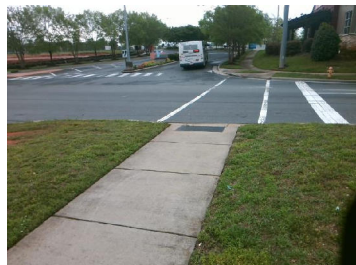
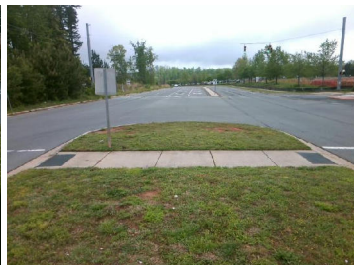
Compliance	Description	Data	Compliance	Description	Data
Yes	Refuge 1 Length (In)	150.0	N/A	Gutter 1 Ponding?	N/A
Yes	Refuge 1 Width (In)	73.0	N/A	Gutter 1 Lip Ht (In)	N/A
Yes	Refuge 1 Slope (%)	3.3	N/A	Gutter 1 Slope (%)	N/A
Yes	Refuge 1 X Slope (%)	2.0	N/A	Gutter 1 X Slope (%)	N/A
N/A	Painted X Walk1?	Yes	N/A	DWS 1 Provided?	N/A
N/A	X Walk 1 Direction	To NW	N/A	DWS 1 Contrast?	N/A
N/A	X Walk 1 Width (In)	108.0	N/A	DWS 1 Length (In)	N/A
N/A	Road 1 Slope (%)	2.3	N/A	DWS 1 Full Width?	N/A
N/A	Road 1 X Slope (%)	1.0	N/A	DWS 1 Offset (In)	N/A
Yes	Refuge 2 Length (In)	150.0	N/A	Gutter 2 Ponding?	N/A
Yes	Refuge 2 Width (In)	73.0	N/A	Gutter 2 Lip Ht (In)	N/A
Yes	Refuge 2 Slope (%)	4.5	N/A	Gutter 2 Slope (%)	N/A
Yes	Refuge 2 X Slope (%)	3.2	N/A	Gutter 2 X Slope (%)	N/A
N/A	Painted X Walk2?	Yes	N/A	DWS 2 Provided?	N/A
N/A	X Walk 2 Direction	To SE	N/A	DWS 2 Contrast?	N/A
N/A	X Walk 2 Width (In)	108.0	N/A	DWS 2 Length (In)	N/A

N/A	Road 2 Slope (%)	3.0	N/A	DWS 2 Full Width?	N/A
N/A	Road 2 X Slope (%)	3.9	N/A	DWS 2 Offset (In)	N/A
N/A	Refuge 3 Length (in)	N/A	N/A	Gutter 3 Ponding?	N/A
N/A	Refuge 3 Width (in)	N/A	N/A	Gutter 3 Lip Ht (in)	N/A
N/A	Refuge 3 Slope (%)	N/A	N/A	Gutter 3 Slope (%)	N/A
N/A	Refuge 3 XSlope (%)	N/A	N/A	Gutter 3 XSlope (%)	N/A
N/A	Painted X Walk3?	N/A	N/A	DWS 3 Provided?	N/A
N/A	X Walk 3 Direction	N/A	N/A	DWS 3 Contrast?	N/A
N/A	X Walk 3 Width (in)	N/A	N/A	DWS 3 Length (in)	N/A
N/A	Road 3 Slope (%)	N/A	N/A	DWS 3 Full Width?	N/A
N/A	Road 3 XSlope (%)	N/A	N/A	DWS 3 Offset (in)	N/A
Yes	Any Obstructions?	N/A	N/A	Storm Grate/Utility Hazard?	N/A
N/A	Obstruction Type		N/A	Storm Grate/Utility Type	
		N/A			N/A
N/A	Surface Condition	Good

Remove & Replace Entire Refuge.
