Access Compliance Report

Public Rights-of-Way

(Island Curb Cuts)

Intersection ID: 17169	Main Street: IDLEWILD_RD	Cross Street: CEDARS_EAST_CT	Location: SE
ADA ID: 6BAA4479AE0F	Curb Cut Type: MedianRefuge2	Initial Pass/Fail: Fail	Overall Compliance: No
Codes/Mitigation Info/Possible Solution		Field Measurements/Component Compliance	
Severity Score: 0

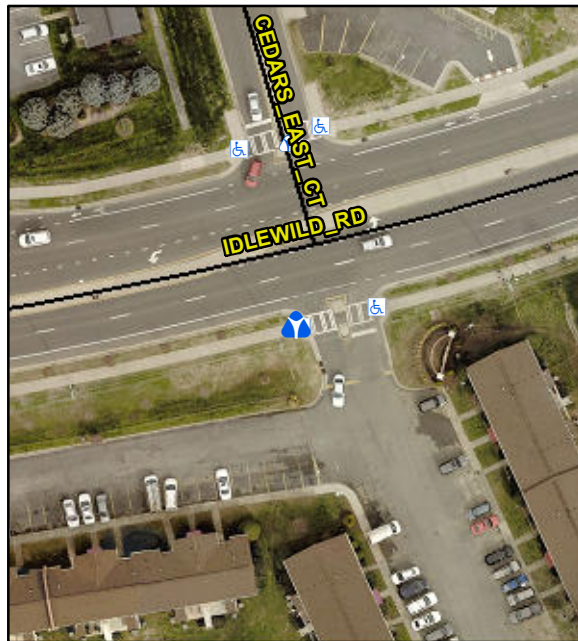
Compliance	Description	Data	Compliance	Description	Data
No	Refuge 1 Length (In)	30.0	N/A	Gutter 1 Ponding?	N/A
Yes	Refuge 1 Width (In)	72.0	N/A	Gutter 1 Lip Ht (In)	N/A
Yes	Refuge 1 Slope (%)	1.2	N/A	Gutter 1 Slope (%)	N/A
Yes	Refuge 1 X Slope (%)	3.0	N/A	Gutter 1 X Slope (%)	N/A
N/A	Painted X Walk1?	Yes	N/A	DWS 1 Provided?	N/A
N/A	X Walk 1 Direction	To SW	N/A	DWS 1 Contrast?	N/A
N/A	X Walk 1 Width (In)	112.0	N/A	DWS 1 Length (In)	N/A
N/A	Road 1 Slope (%)	1.8	N/A	DWS 1 Full Width?	N/A
N/A	Road 1 X Slope (%)	0.7	N/A	DWS 1 Offset (In)	N/A
No	Refuge 2 Length (In)	30.0	N/A	Gutter 2 Ponding?	N/A
Yes	Refuge 2 Width (In)	72.0	N/A	Gutter 2 Lip Ht (In)	N/A
Yes	Refuge 2 Slope (%)	0.1	N/A	Gutter 2 Slope (%)	N/A
Yes	Refuge 2 X Slope (%)	4.0	N/A	Gutter 2 X Slope (%)	N/A
N/A	Painted X Walk2?	Yes	N/A	DWS 2 Provided?	N/A
N/A	X Walk 2 Direction	To NE	N/A	DWS 2 Contrast?	N/A
N/A	X Walk 2 Width (In)	111.0	N/A	DWS 2 Length (In)	N/A

N/A	Road 2 Slope (%)	0.1	N/A	DWS 2 Full Width?	N/A
N/A	Road 2 X Slope (%)	0.5	N/A	DWS 2 Offset (In)	N/A
N/A	Refuge 3 Length (in)	N/A	N/A	Gutter 3 Ponding?	N/A
N/A	Refuge 3 Width (in)	N/A	N/A	Gutter 3 Lip Ht (in)	N/A
N/A	Refuge 3 Slope (%)	N/A	N/A	Gutter 3 Slope (%)	N/A
N/A	Refuge 3 XSlope (%)	N/A	N/A	Gutter 3 XSlope (%)	N/A
N/A	Painted X Walk3?	N/A	N/A	DWS 3 Provided?	N/A
N/A	X Walk 3 Direction	N/A	N/A	DWS 3 Contrast?	N/A
N/A	X Walk 3 Width (in)	N/A	N/A	DWS 3 Length (in)	N/A
N/A	Road 3 Slope (%)	N/A	N/A	DWS 3 Full Width?	N/A
N/A	Road 3 XSlope (%)	N/A	N/A	DWS 3 Offset (in)	N/A
Yes	Any Obstructions?	N/A	N/A	Storm Grate/Utility Hazard?	N/A
N/A	Obstruction Type		N/A	Storm Grate/Utility Type	
		N/A			N/A
N/A	Surface Condition	Good

Remove & Replace Entire Refuge.

Total Cost: \$ 3000.00
