Access Compliance Report

Public Rights-of-Way

(Island Curb Cuts)

Intersection ID: 44555	Main Street: UNIVERSITY_CITY_BV	Cross Street: N_TRYON_ST	Location:	W
ADA ID: 6C2F84AED502	Curb Cut Type: MedianRefuge2	Initial Pass/Fail: Pass	Overall Compliance: No	Severity Score: 12.5

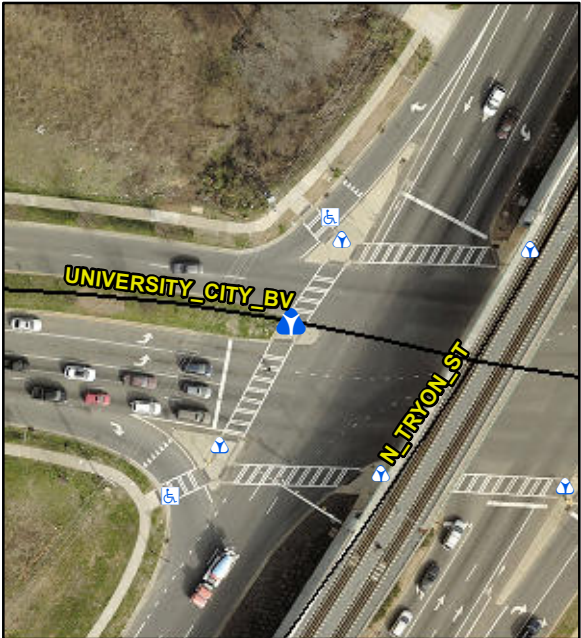
Possible Solutions:		Compliance	Description	Data
	Remove & Replace Detectable Warning System. Grind Gutter Lip. Remove & Replace Gutter.		Yes	Refuge 1 Length (In)	82.5
			Yes	Refuge 1 Width (In)	122.0
			Yes	Refuge 1 Slope (%)	0.3
			Yes	Refuge 1 X Slope (%)	1.3
			N/A	Painted X Walk1?	Yes
			N/A	X Walk 1 Direction	To S
			N/A	X Walk 1 Width (In)	117.0
			N/A	Road 1 Slope (%)	1.9
			N/A	Road 1 X Slope (%)	0.1
<p>Surveyor Notes:</p> <p>N/A</p>			Yes	Refuge 2 Length (In)	82.5
			Yes	Refuge 2 Width (In)	122.0
			Yes	Refuge 2 Slope (%)	1.3
			Yes	Refuge 2 X Slope (%)	1.1
			N/A	Painted X Walk2?	Yes
			N/A	X Walk 2 Direction	To N
			N/A	X Walk 2 Width (In)	130.0
			N/A	Road 2 Slope (%)	1.4
			N/A	Road 2 X Slope (%)	1.3
			N/A	Refuge 3 Length (in)	N/A
<p>PROW/ADA:</p> <p>N/A</p>			No	Gutter 1 Ponding?	Yes
			No	Gutter 1 Lip Ht (In)	0.5

Yes	Gutter 1 Slope (%)	2.8
			No	Gutter 1 X Slope (%)	4.1
			Yes	DWS 1 Provided?	Yes
			Yes	DWS 1 Contrast?	Yes
			No	DWS 1 Length (In)	23.5
			No	DWS 1 Full Width?	No
			Yes	DWS 1 Offset (In)	0.0
			No	Gutter 2 Ponding?	Yes
<p>Total Cost:</p> <p>\$ 2550.00</p>			No	Gutter 2 Lip Ht (In)	0.25
			Yes	Gutter 2 Slope (%)	0.2
			Yes	Gutter 2 X Slope (%)	0.2
			Yes	DWS 2 Provided?	Yes
			Yes	DWS 2 Contrast?	Yes
			Yes	DWS 2 Length (In)	24.0
			No	DWS 2 Full Width?	No
			Yes	DWS 2 Offset (In)	0.0
			N/A	Gutter 3 Ponding?	No
			N/A	Gutter 3 Lip Ht (in)	N/A
