# Access Compliance Report

## Public Rights-of-Way

### (Island Curb Cuts)

Intersection ID: 13713	Main Street: UNIVERSITY POINTE BV	Cross Street: IBM DR	Location:	E
ADA ID: 6C786B876ECA	Curb Cut Type: MedianRefuge2	Initial Pass/Fail: Pass	Overall Compliance: No	Severity Score: 30
Codes/Mitigation Info/Possible Solution		Field Measurements/Component Compliance

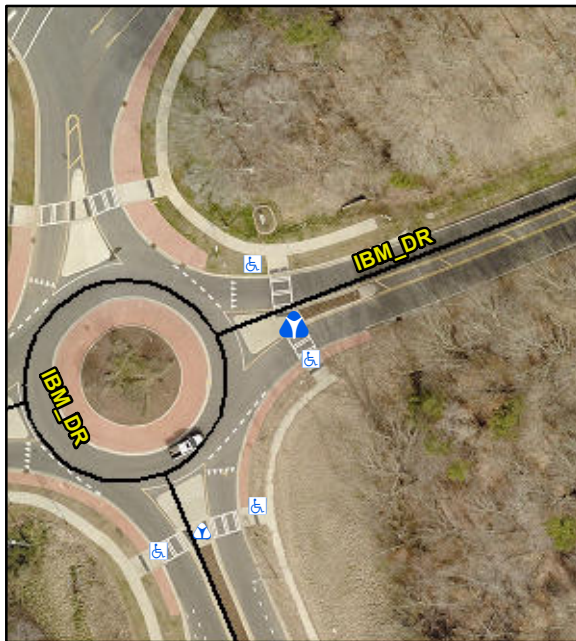
Compliance	Description	Data	Compliance	Description	Data
Yes	Refuge 1 Length (In)	45.0	Yes	Gutter 1 Ponding?	No
Yes	Refuge 1 Width (In)	122.5	No	Gutter 1 Lip Ht (In)	1.5
Yes	Refuge 1 Slope (%)	1.6	No	Gutter 1 Slope (%)	6.2
Yes	Refuge 1 X Slope (%)	0.6	Yes	Gutter 1 X Slope (%)	0.6
N/A	Painted X Walk1?	No	Yes	DWS 1 Provided?	Yes
N/A	X Walk 1 Direction	To N	Yes	DWS 1 Contrast?	Yes
N/A	X Walk 1 Width (In)	N/A	Yes	DWS 1 Length (In)	24.0
N/A	Road 1 Slope (%)	1.1	Yes	DWS 1 Full Width?	Yes
N/A	Road 1 X Slope (%)	3.7	No	DWS 1 Offset (In)	4.0
Yes	Refuge 2 Length (In)	45.0	No	Gutter 2 Ponding?	Yes
Yes	Refuge 2 Width (In)	122.5	No	Gutter 2 Lip Ht (In)	1.75
Yes	Refuge 2 Slope (%)	0.5	Yes	Gutter 2 Slope (%)	1.8
Yes	Refuge 2 X Slope (%)	1.6	Yes	Gutter 2 X Slope (%)	1.0
N/A	Painted X Walk2?	No	Yes	DWS 2 Provided?	Yes
N/A	X Walk 2 Direction	To S	Yes	DWS 2 Contrast?	Yes
N/A	X Walk 2 Width (In)	N/A	Yes	DWS 2 Length (In)	24.0

N/A	Road 2 Slope (%)	1.1	No	DWS 2 Full Width?	No
N/A	Road 2 X Slope (%)	1.5	No	DWS 2 Offset (In)	4.5
N/A	Refuge 3 Length (in)	N/A	N/A	Gutter 3 Ponding?	No
N/A	Refuge 3 Width (in)	N/A	N/A	Gutter 3 Lip Ht (in)	N/A
N/A	Refuge 3 Slope (%)	N/A	N/A	Gutter 3 Slope (%)	N/A
N/A	Refuge 3 XSlope (%)	N/A	N/A	Gutter 3 XSlope (%)	N/A
N/A	Painted X Walk3?	No	N/A	DWS 3 Provided?	N/A
N/A	X Walk 3 Direction	N/A	N/A	DWS 3 Contrast?	N/A
N/A	X Walk 3 Width (in)	N/A	N/A	DWS 3 Length (in)	N/A
N/A	Road 3 Slope (%)	N/A	N/A	DWS 3 Full Width?	N/A
N/A	Road 3 XSlope (%)	N/A	N/A	DWS 3 Offset (in)	N/A
Yes	Any Obstructions?	No	N/A	Storm Grate/Utility Hazard?	No
N/A	Obstruction Type		N/A	Storm Grate/Utility Type	
N/A	Surface Condition	Good			N/A

Possible Solutions:

**Remove & Replace Detectable Warning System. Grind Gutter Lip. Remove & Replace Gutter.**
