Access Compliance Report

Public Rights-of-Way

(Island Curb Cuts)

Intersection ID: 12695	Main Street: S_CALDWELL_ST	Cross Street: E_TRADE_ST	Location: W
ADA ID: 6D80D7CA18F0	Curb Cut Type: MedianRefuge2	Initial Pass/Fail: Fail	Overall Compliance: No
Severity Score: 12.5			
Codes/Mitigation Info/Possible Solution		Field Measurements/Component Compliance

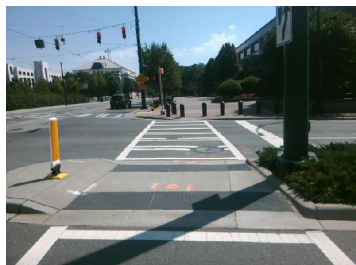
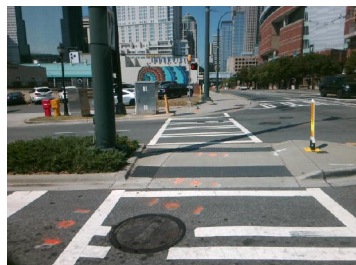
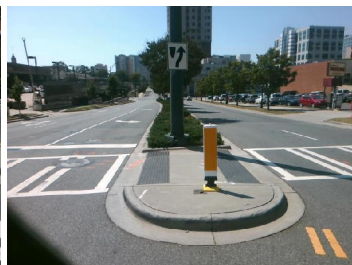
Compliance	Description	Data	Compliance	Description	Data
Yes	Refuge 1 Length (In)	47.5	N/A	Gutter 1 Ponding?	N/A
Yes	Refuge 1 Width (In)	114.0	N/A	Gutter 1 Lip Ht (In)	N/A
Yes	Refuge 1 Slope (%)	4.0	N/A	Gutter 1 Slope (%)	N/A
Yes	Refuge 1 X Slope (%)	3.0	N/A	Gutter 1 X Slope (%)	N/A
N/A	Painted X Walk1?	Yes	N/A	DWS 1 Provided?	N/A
N/A	X Walk 1 Direction	To SE	N/A	DWS 1 Contrast?	N/A
N/A	X Walk 1 Width (In)	111.0	N/A	DWS 1 Length (In)	N/A
N/A	Road 1 Slope (%)	6.4	N/A	DWS 1 Full Width?	N/A
N/A	Road 1 X Slope (%)	2.4	N/A	DWS 1 Offset (In)	N/A
Yes	Refuge 2 Length (In)	47.5	N/A	Gutter 2 Ponding?	N/A
Yes	Refuge 2 Width (In)	128.0	N/A	Gutter 2 Lip Ht (In)	N/A
No	Refuge 2 Slope (%)	5.2	N/A	Gutter 2 Slope (%)	N/A
Yes	Refuge 2 X Slope (%)	2.6	N/A	Gutter 2 X Slope (%)	N/A
N/A	Painted X Walk2?	Yes	N/A	DWS 2 Provided?	N/A
N/A	X Walk 2 Direction	To NW	N/A	DWS 2 Contrast?	N/A
N/A	X Walk 2 Width (In)	111.0	N/A	DWS 2 Length (In)	N/A

N/A	Road 2 Slope (%)	4.7	N/A	DWS 2 Full Width?	N/A
N/A	Road 2 X Slope (%)	0.8	N/A	DWS 2 Offset (In)	N/A
N/A	Refuge 3 Length (in)	N/A	N/A	Gutter 3 Ponding?	N/A
N/A	Refuge 3 Width (in)	N/A	N/A	Gutter 3 Lip Ht (in)	N/A
N/A	Refuge 3 Slope (%)	N/A	N/A	Gutter 3 Slope (%)	N/A
N/A	Refuge 3 XSlope (%)	N/A	N/A	Gutter 3 XSlope (%)	N/A
N/A	Painted X Walk3?	N/A	N/A	DWS 3 Provided?	N/A
N/A	X Walk 3 Direction	N/A	N/A	DWS 3 Contrast?	N/A
N/A	X Walk 3 Width (in)	N/A	N/A	DWS 3 Length (in)	N/A
N/A	Road 3 Slope (%)	N/A	N/A	DWS 3 Full Width?	N/A
N/A	Road 3 XSlope (%)	N/A	N/A	DWS 3 Offset (in)	N/A
Yes	Any Obstructions?	N/A	N/A	Storm Grate/Utility Hazard?	N/A
N/A	Obstruction Type		N/A	Storm Grate/Utility Type	
		N/A			N/A
N/A	Surface Condition	Good

Remove & Replace Entire Refuge.

\$ 3000.00
