Access Compliance Report

Public Rights-of-Way

(Island Curb Cuts)

Intersection ID: 53421	Main Street: ARDREY_KELL_RD	Cross Street: N/A	Location: W
ADA ID: 6F5A5FF2FB32	Curb Cut Type: MedianRefuge2	Initial Pass/Fail: Fail	Overall Compliance: No
Severity Score: 1.25			
Codes/Mitigation Info/Possible Solution		Field Measurements/Component Compliance

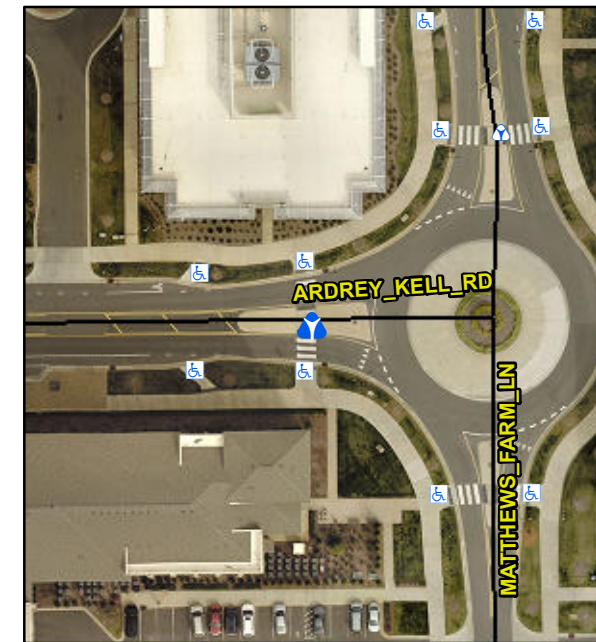
Compliance	Description	Data	Compliance	Description	Data
Yes	Refuge 1 Length (In)	83.5	N/A	Gutter 1 Ponding?	N/A
Yes	Refuge 1 Width (In)	120.0	N/A	Gutter 1 Lip Ht (In)	N/A
Yes	Refuge 1 Slope (%)	0.8	N/A	Gutter 1 Slope (%)	N/A
Yes	Refuge 1 X Slope (%)	2.9	N/A	Gutter 1 X Slope (%)	N/A
N/A	Painted X Walk1?	Yes	N/A	DWS 1 Provided?	N/A
N/A	X Walk 1 Direction	To S	N/A	DWS 1 Contrast?	N/A
N/A	X Walk 1 Width (In)	121.0	N/A	DWS 1 Length (In)	N/A
N/A	Road 1 Slope (%)	0.3	N/A	DWS 1 Full Width?	N/A
N/A	Road 1 X Slope (%)	3.2	N/A	DWS 1 Offset (In)	N/A
Yes	Refuge 2 Length (In)	83.5	N/A	Gutter 2 Ponding?	N/A
Yes	Refuge 2 Width (In)	120.0	N/A	Gutter 2 Lip Ht (In)	N/A
Yes	Refuge 2 Slope (%)	2.6	N/A	Gutter 2 Slope (%)	N/A
Yes	Refuge 2 X Slope (%)	1.0	N/A	Gutter 2 X Slope (%)	N/A
N/A	Painted X Walk2?	Yes	N/A	DWS 2 Provided?	N/A
N/A	X Walk 2 Direction	To N	N/A	DWS 2 Contrast?	N/A
N/A	X Walk 2 Width (In)	120.0	N/A	DWS 2 Length (In)	N/A

N/A	Road 2 Slope (%)	0.2	N/A	DWS 2 Full Width?	N/A
N/A	Road 2 X Slope (%)	2.3	N/A	DWS 2 Offset (In)	N/A
N/A	Refuge 3 Length (in)	N/A	N/A	Gutter 3 Ponding?	N/A
N/A	Refuge 3 Width (in)	N/A	N/A	Gutter 3 Lip Ht (in)	N/A
N/A	Refuge 3 Slope (%)	N/A	N/A	Gutter 3 Slope (%)	N/A
N/A	Refuge 3 XSlope (%)	N/A	N/A	Gutter 3 XSlope (%)	N/A
N/A	Painted X Walk3?	N/A	N/A	DWS 3 Provided?	N/A
N/A	X Walk 3 Direction	N/A	N/A	DWS 3 Contrast?	N/A
N/A	X Walk 3 Width (in)	N/A	N/A	DWS 3 Length (in)	N/A
N/A	Road 3 Slope (%)	N/A	N/A	DWS 3 Full Width?	N/A
N/A	Road 3 XSlope (%)	N/A	N/A	DWS 3 Offset (in)	N/A
Yes	Any Obstructions?	N/A	N/A	Storm Grate/Utility Hazard?	N/A
N/A	Obstruction Type		N/A	Storm Grate/Utility Type	
		N/A			N/A
N/A	Surface Condition	Good

Possible Solutions:

Remove & Replace Entire Refuge.

Total Cost: \$ 3000.00
