Access Compliance Report

Public Rights-of-Way

(Island Curb Cuts)

| Intersection ID: 10025681 | Main Street: EAST_BV | Cross Street: N/A | Location: N |

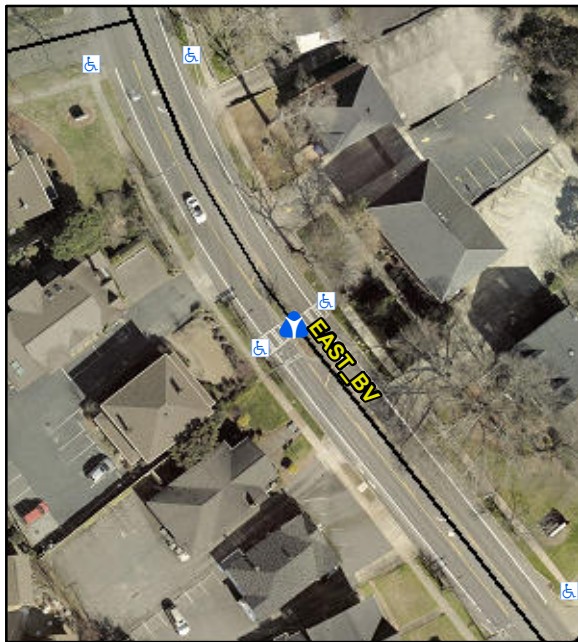
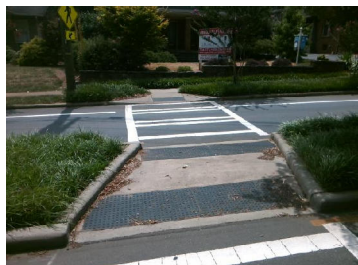
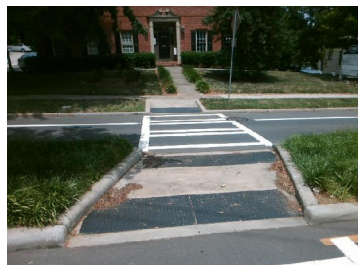
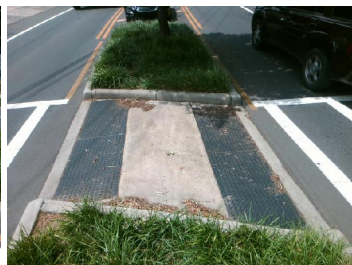
| ADA ID: 713D21928452 | Curb Cut Type: MedianRefuge2 | Initial Pass/Fail: Fail | Overall Compliance: No |

| Compliance | Description | Data | Compliance | Description | Data |
|---|---|---|---|---|---|
| No | Refuge 1 Slope (%) | 5.1 | N/A | Gutter 1 Slope (%) | N/A |

Remove & Replace Entire Refuge.
